Atlantic Shore Line
Locomotive 100
Curatorial Report no. 2
1 – 16 January 2007
by Donald G. Curry, Interim Shop Manager
Seashore Trolley Museum

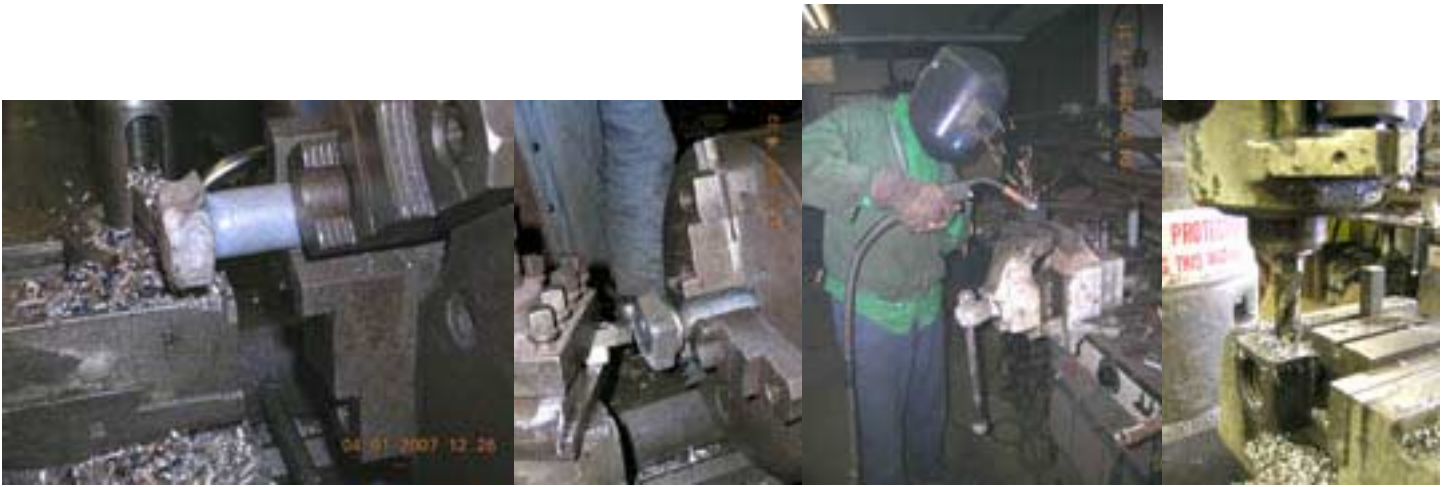
Correcting eroded heads – The heads of 13 of these original bolts had corroded so badly that it was necessary for **Dean** to make new ones.³ Using our American lathe, he turned the remains of the head round; then turned on a 1 1/2 in. coarse thread. On to that he screwed a large 1 1/2 in. square nut (of which we had quite a number in stock). This was then tack-welded in place. He then turned the shoulder on the bottom of the new head. The last steps were to:

Remaking the square-headed motor frame bolts
Dean Look welding

1. Mill the head 1 7/8 in. sq. with the Bridgeport milling machine.
2. Mill the thickness of the head just slightly higher than the original had been
3. Turn a chamfer on the top of the head to match the original
4. Fill the hole in the top of the head with weld
5. Mill the welding flat.

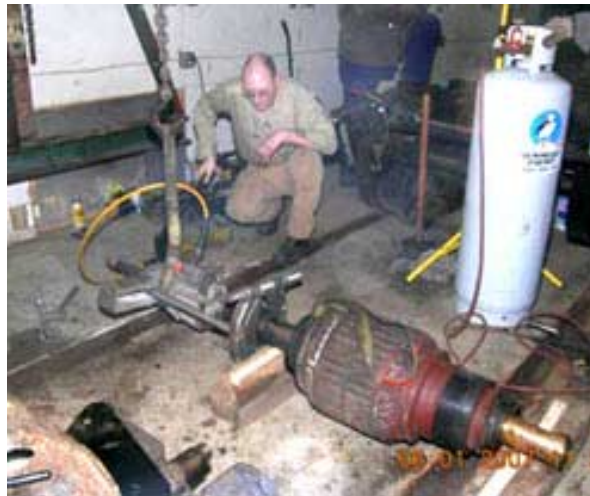
In the last report, we described the pinions and how they came off. The pinion on the no. 1 motor had refused to come loose despite gentle heating, intense pulling and beating. In fact we broke two pinion pullers in the process!

Don Landry pulling the pinion.

As we wondered why this pinion was so resistant, Don ‘opined’ that it was probably installed using too much heat rather than the gentler method of placing it in boiling water, that we traditionally use. This motor is on the only original A.S.L. axle, meaning it possibly may have been on longer than the others, although motor repairs are not necessarily related to axle work. The pinion is a Nuttall, a subsidiary of Westinghouse Electric.

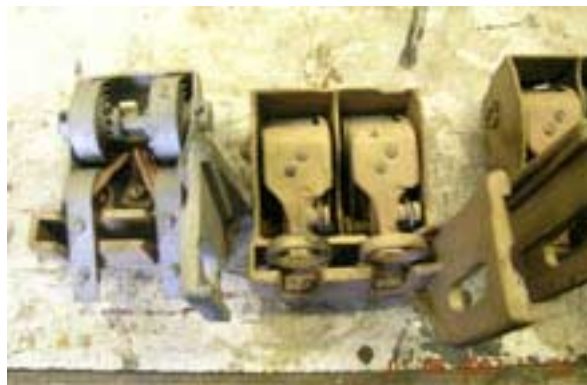
Generally the brushholders are in very good condition with all springs working and seem to have the correct tension. The housings have been subjected to various ‘episodes’ which have burned some holes in them but not enough to require repairs.

Clock spring an older type brushholders

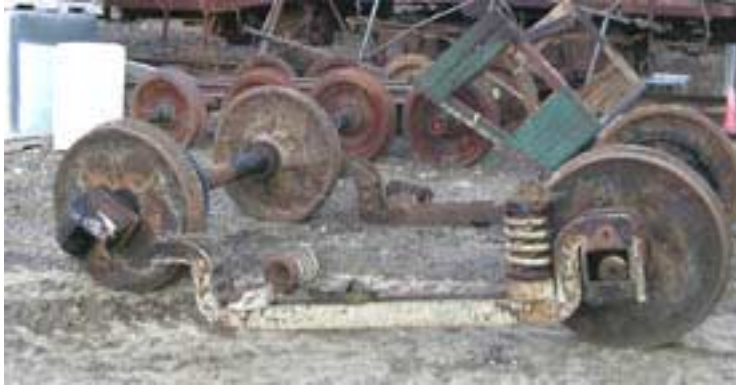
Equalizers, springs, journal boxes and wheel sets

Most of the equalizer coil spring sets came out of their bottom mounting ‘cups’ but several also were stuck with a major buildup of rust and required a bit of ‘persuasion’.

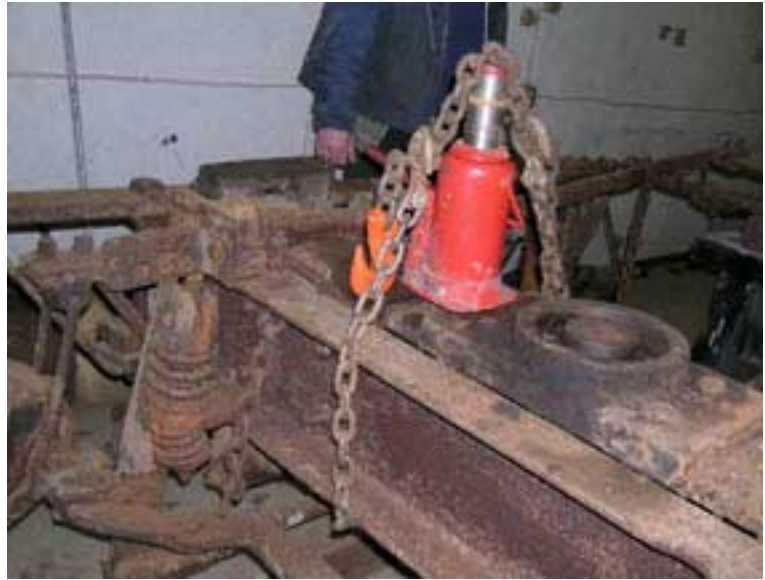
Randy Bogucki driving out swing link bracket bolt
Squeezing the bolster elliptic springs

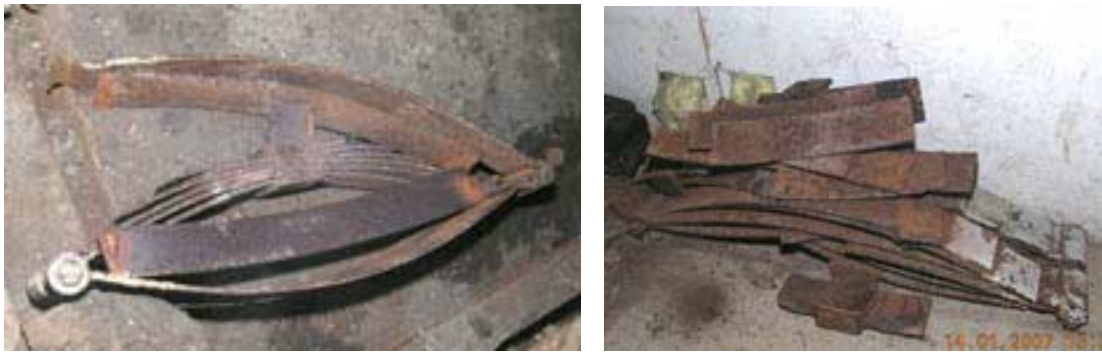
- Truck bolsters (1) seem to be in excellent condition with little corrosion. Center bearings look like new and there is virtually no wear anywhere.
- Double - Elliptic (bolster) springs (two sets) – Under each side end of the bolster are actually four springs making a double 'full elliptic' set. One spring arches up at the center and the other arches down, with the ends of each pair bent to form a 'football' shaped loop through which 'binding' bolts holds both pairs together. On our first inspection of the trucks, what little we could see of the springs was not encouraging and that was confirmed when the bolsters were removed. The springs on the no. 1 truck virtually disintegrated into a pile of barely recognizable scrap iron when they were removed. Corrosion had eaten away at the lower leaves and forced them apart, breaking the binding clamps. Those on the no. 2 truck have been released but not removed as yet, but possibly are marginally better.

Disintegrated elliptical bolster springs
