Atlantic Shore Line Railway Locomotive 100
Curatorial Report no. 5
21 February – 18 March, 2007
Donald G. Curry, Interim Shop Manager
Seashore Trolley Museum

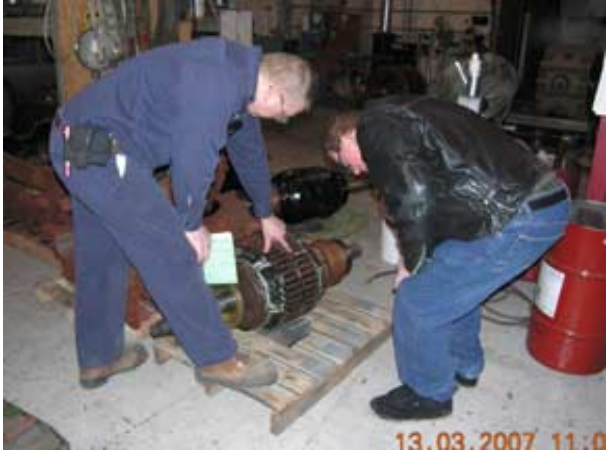
- Armatures – All 4 armatures have been cleaned, baked and their insulation resistance measured. Three of them have very high resistance—500 'megs', which is excellent. These have been given coats of insulating varnish. The fourth started with resistance of one meg and that has dropped to about 0.5 meg. Without destructive testing it is difficult to tell where the problem might be but he pointed out a small

damaged area in the armature core which had been ground away in an earlier repair. While the motor would be very likely to run satisfactorily in this condition, it should be watched. At this point he is not prepared to say whether it should be re-wound or not.

Roger Paradie and Dan Cohen inspecting the questionable motor armature.

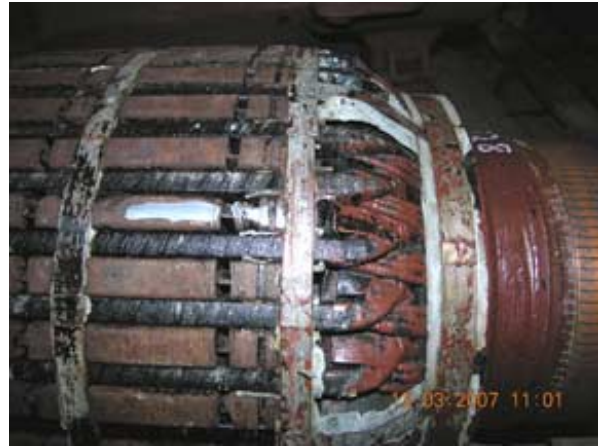
Detail of the potential problem area

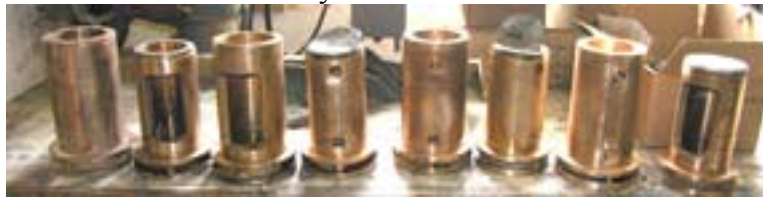
- Armature bearings – We now have all eight bronze armature bearing shells, returned from A.C. There is virtually no babbitt metal remaining in them, and as stated in previous reports, they are worn as much as 3/16 in. oversize! Before we send them to American Power Service for re-babbitting, we are going to carefully inspect the two locating holes in each shells that keep the bronze bearing from rotating in the motor case. These are supposed to be 41/64 in. diameter, about 0.0156 in. larger than the dowel pins in the bearing saddles.³ Over time, the bearing tends to work itself loose under the saddle and rotate slightly, tending to wear these holes to an oval shape. A cursory examination reveals 1) that they are in pretty good shape but worn somewhat, 2) that some have been repaired previously.⁴ During yesterday's visit, we noted that a number of the 5/8 in. dowel pins in the bearing saddles had also worn and we may well be able to limit bearing rotation by replacing the pins as we did in 639's ex-Type 5 trucks. Those in 100 are far less worn but should come out easily.

Armature bearings are received back from A. C.

We also noticed the shells have worn on the outside, again due to this slight rotation. There is a definite 'parting mark' at along each side where the saddle clamps down on them. We are not quite sure whether to ignore this (depending on how loose they actually turn out to be), shim the outside of the bearing or even mill off a very slight amount from the bearing saddle to give a slight clamping action.

- Re-babbitting – Before we can have them done, we need to know the diameter of the motor shafts. Roger has measured them and thinks that we can have three at one diameter but one (the one in the lathe) requires truing up so will be slightly smaller. Although we will do the actual bearing machining, we want to be certain there is enough babbit lining so we can turn them to the proper diameter plus clearance. According to the Wisconsin Utilities *Standard Maintenance Guide for Railway Equipment* August 1929⁵, the following clearances should be followed:

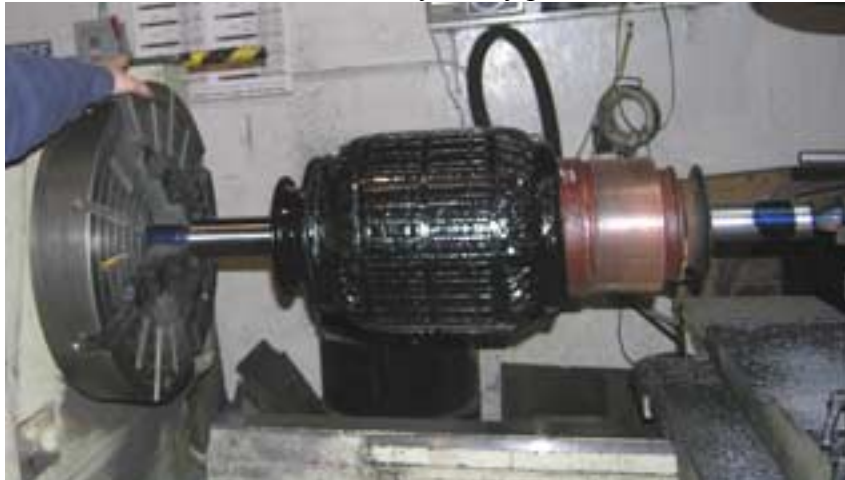
On the shaft that was in the lathe we noticed the bluing that remained after the initial turning and there was quite a hollow in one place. The other end had been very nicely polished.

Armature in the lathe for truing the shaft.
(The blue area on the right shaft is a 'low' area.)

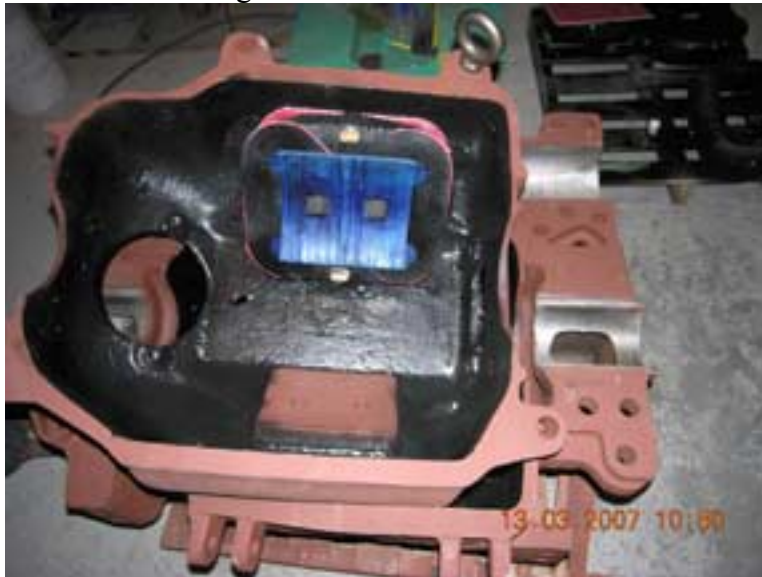
- The cases – Everywhere we looked we saw parts for 100. The cases, which left STM still covered with heavy layers of grime and rust, were now beautifully cleaned up and painted with a red-oxide primer. (They will end up black.) The motors are suspended from these cases by a $\frac{3}{4} \times 5 \frac{1}{2} \times 48$ in. steel plate with four $1 \frac{3}{16}$ in. holes bored in it through which go heavy $1 \frac{1}{8}$ in. bolts. To make these holes we're ordering another *Rotabroach* to be used in the magnetic-base drill.

Case with first field coil installed

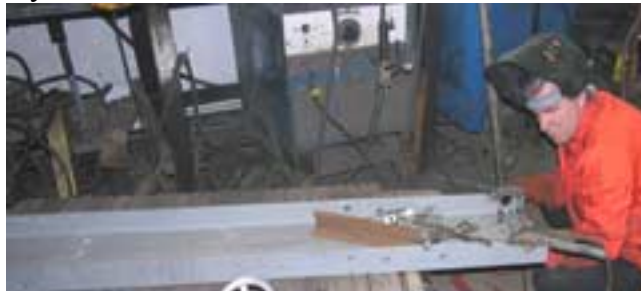
- Transoms are made from 10 in. 30 lb. (per ft.) channel. Unfortunately we weren't able to get any of the full 3 ⅝ in. flange width of the original. We had asked Novel to drill a 1 5/16 in. hole near the end of each, top and bottom, flange for the large vertical tie bolts in that location. The hole had to be located in what would have been the center of the original flange width but was too close to the edge of the 3 in. width. So, last week, **Bill Pollman** welded strips of ½ in. steel about 4 in. long to extend the width of the flanges. Two of them have been painted with black polyurethane enamel over the gray shop coat. The others will be done shortly.

Bill Pollman welding extension 'ears' on truck transom.

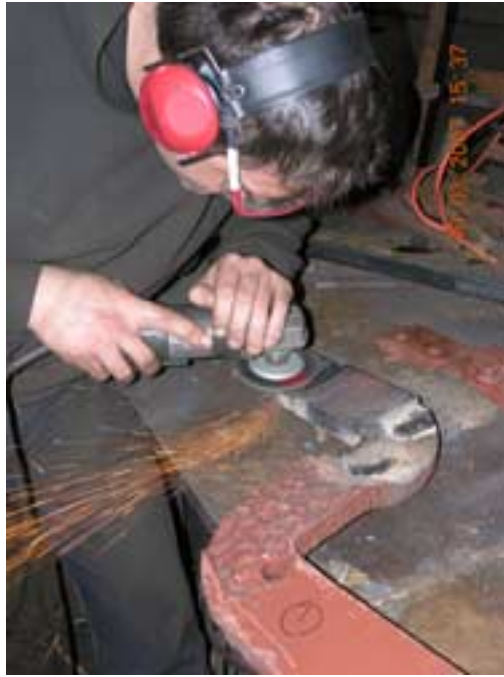
Randy Bogucki grinding the new brake beam end.
Note the extent of the pitting.

As I left the Shop the other day, **Randy Bogucki** was welding the new ends on the badly corroded brake beams. **Norm Down** had been at the sand blaster much of the day removing corrosion and mill scale from truck and sill bolts. We have completed the fabrication of hundreds of new bolts (for 110 and 1160), and are in the process of priming and painting them.
