**Atlantic Shore Line Locomotive 100**  
**Curatorial Report No. 6**  
19-31 March 2007  
by Donald G. Curry, Interim Shop Manager

Seashore Trolley  
Museum  
Locomotive 100

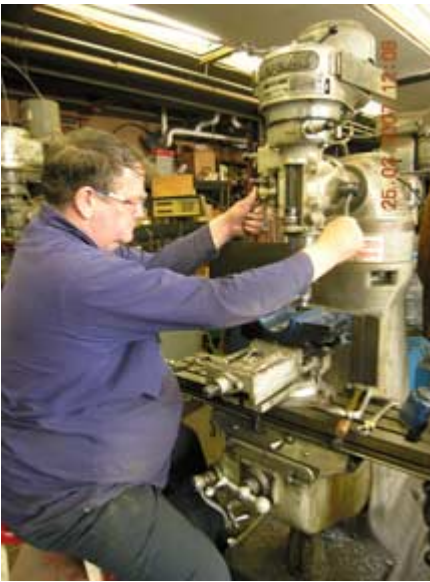
Chuck milling out dowel pins

Bearing caps – These have 5/8 in. steel dowel pins to keep the bearing shells from rotating within the bearing cap. Over time they have worked back and forth causing the pins to wear from round to oval, thus allowing the shells to rotate even more. **Chuck** drilled and milled the old pins out; then **Dean Look** installed new ones.<sup>1</sup> Because the holes in the bearing caps were of various depths, Dean had to grind some that stuck in more than the 5/16 in. called for in the bearing blueprints. The bearing caps will go back to A.C. for the assembly and final testing of the motors.

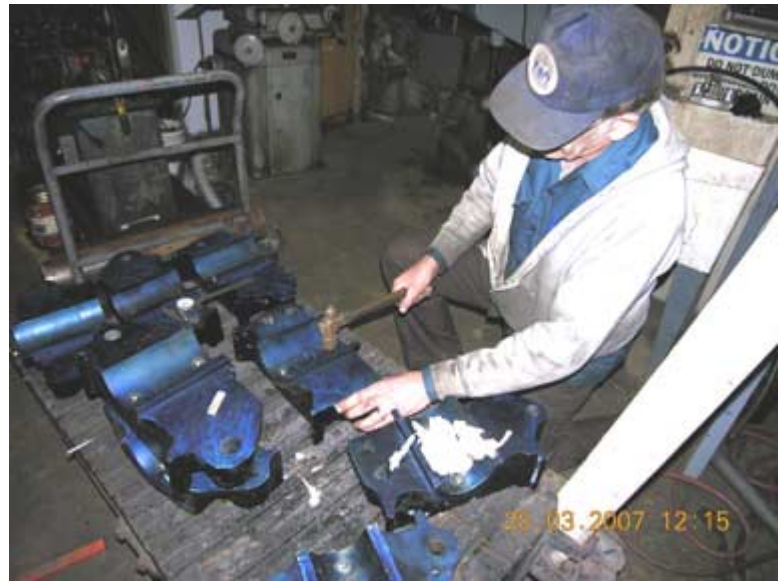
Dean driving in new dowel pins

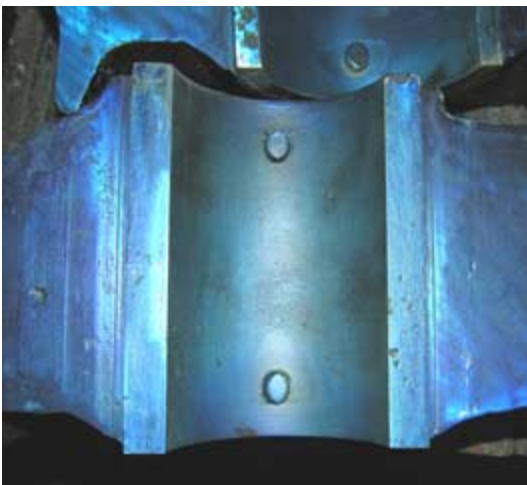
Beat-up dowel pins

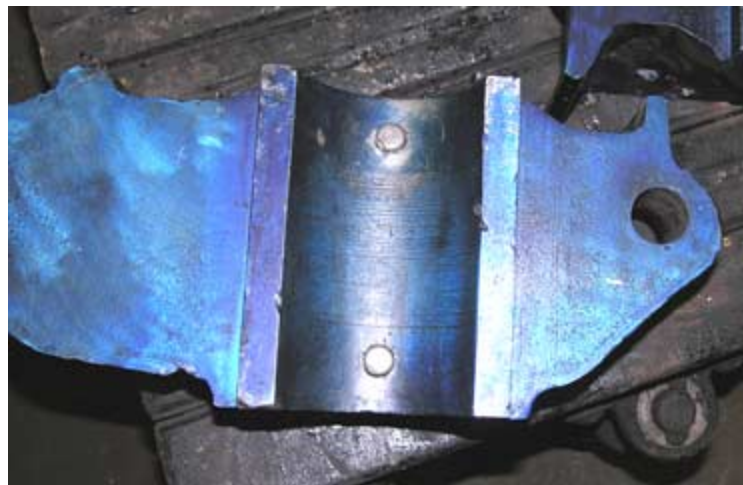
New dowel pins

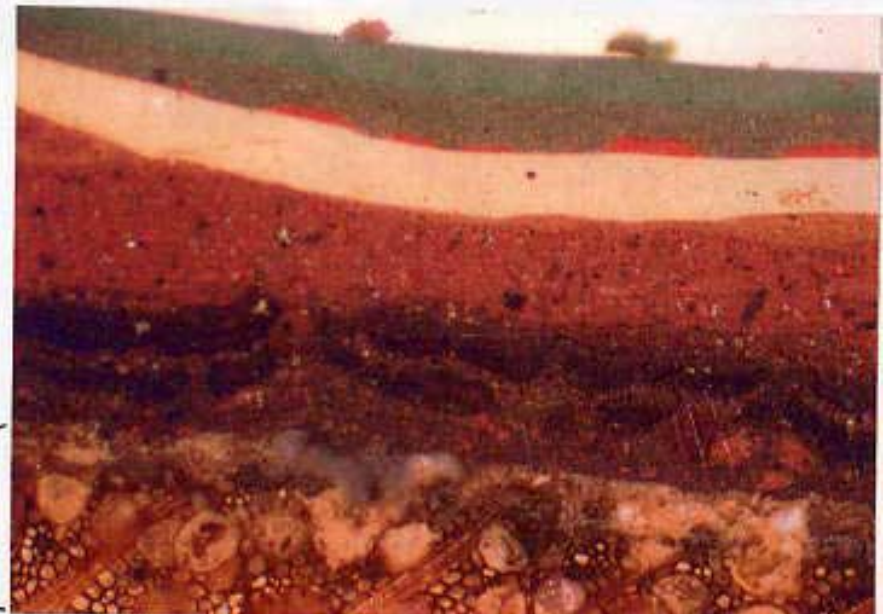
①

Sample #1. Only bits of the original dark treatment survive. This was followed by a medium gray which appears to be a base layer. There follows two treatments which appear as very dark browns in cross section and may appear black when isolated and matched. Both were given clear finishes. They were followed by a red brown, then recent treatments.

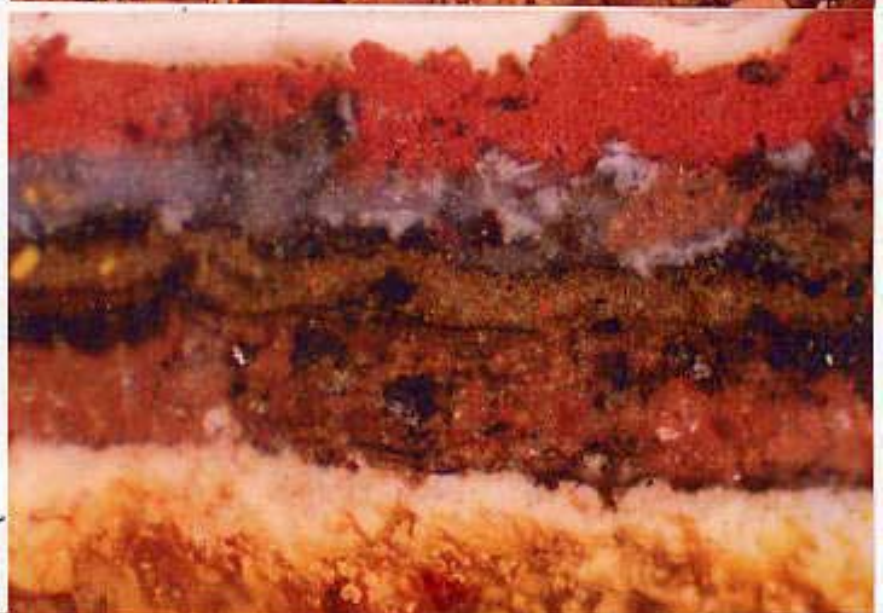
②

Sample #2. This sample starts with (what would probably be if isolated and matched) a rosy tan, followed by two red browns, a greenish brown or brownish olive, then recent treatments.

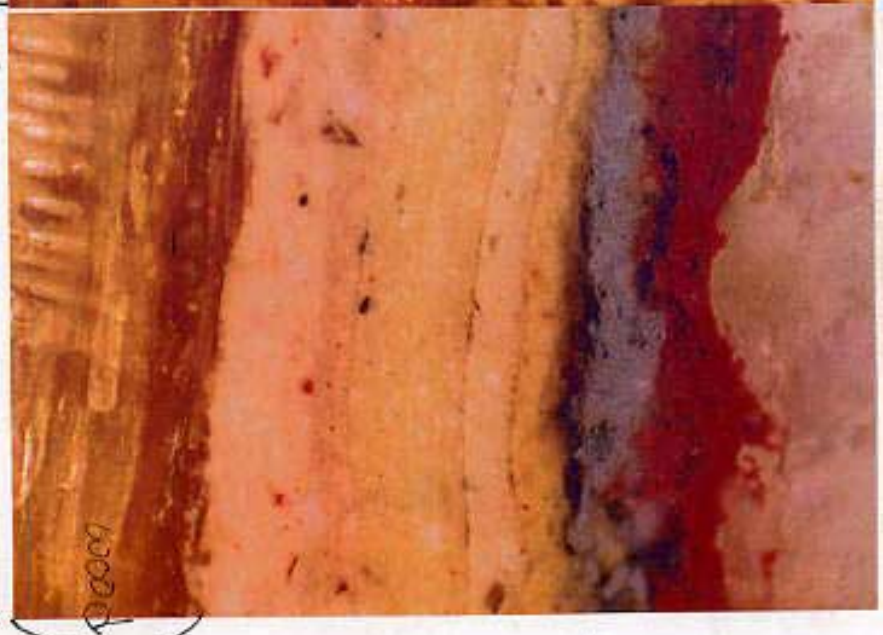
③

Sample #3. This sample begins with a rosy tan which is probably a match to the first treatment of sample #2. It is followed by a yellow, a light tan, a mustardy yellow, then recent treatments. (Again, these are the colors as they appear in cross section.)
