**Atlantic Shore line Locomotive 100**  
**Curatorial Report No. 7**  
1 April--9 September 2007  
*by Donald G. Curry, Shop Manager*

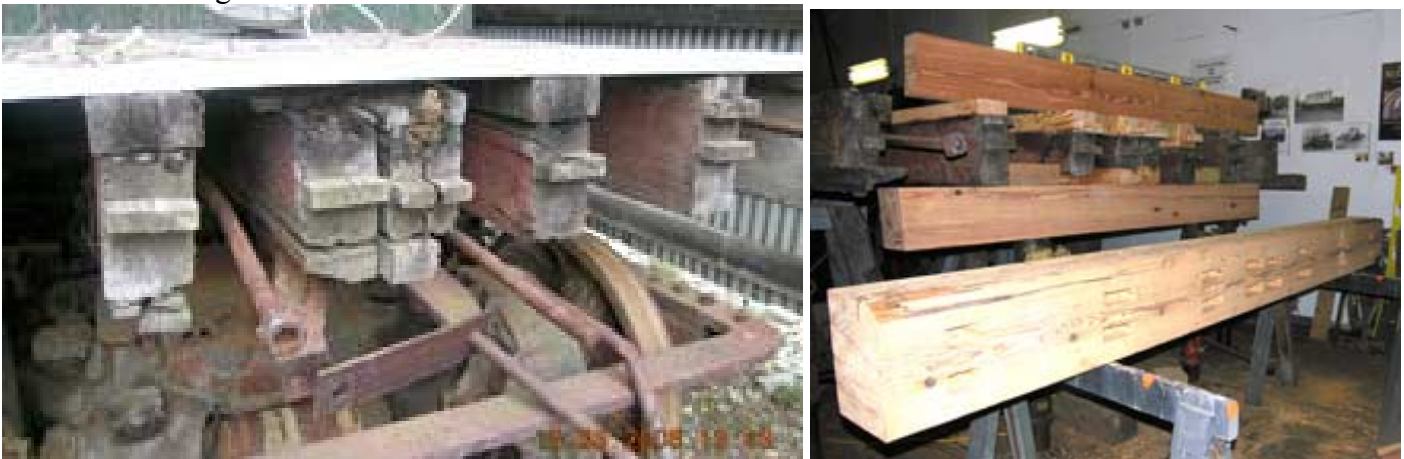
**Step 3. Replace the missing end tenons.** On the end of each sill are two tenons which hold the sills in line and support the big end sills. The tenons range from  $1\frac{3}{8}$  in to  $1\frac{1}{2}$  in thick by 5 in. wide on the inner sills and about 3 in. on the outside sills. A number of them had deteriorated or were missing. We noted that some of the sills had twisted during Laconia's period of building 100. In order to keep the tenons in line, the horizontal surfaces were made level but, because of the twist, they were actually slanted in relation to the sill. This took some careful measuring.

Before and after showing the tenons on the ends of the long sills and the new end sill ready to fit.

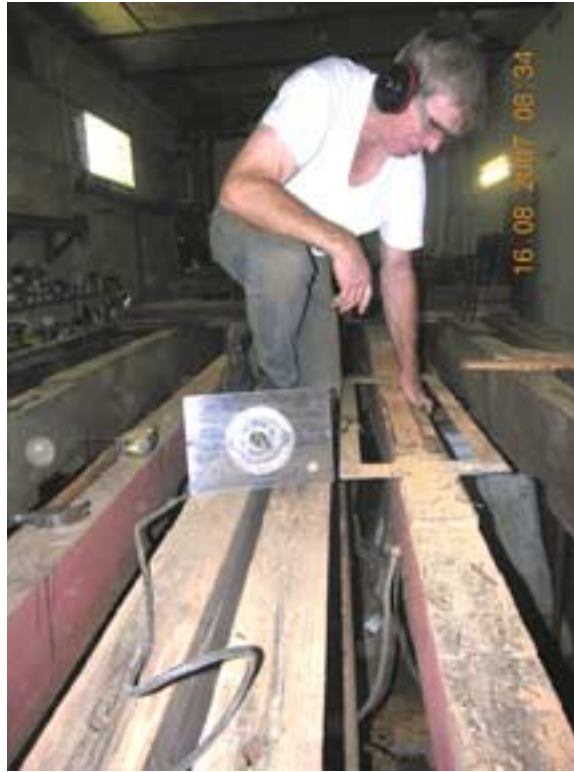
**Step 4. Replace rotted and hollowed-out interiors.** When the locomotive operated, the first parts to move were the trucks. Their force was then transmitted through the truck bolster, the truck center bearing, the body center bearing, the body bolster and finally the body. Holding this all together were the twelve three-quarter in. diameter by 14 in. long square-head bolts which ran down from the top of the sills through the top plate of the bolster. (The end ones went through both plates which came together for their last few inches.) As the car operated, great strains were put on these bolts and the wood surrounding them. As the wood aged, it shrank somewhat allowing the bolts to loosen slightly which then allowed the bolts to work slightly-more and more over time. At the same time, water worked its way down along the bolts, deteriorating the wood as well as the bolts.

Hollowing out deteriorated sill

However, when we removed these plates and their associated bolts, we found most of the holes in the sills had greatly enlarged and needed to be filled. Using a specially purchased 4-in. shank with a 2 in. carbide cutting blade router bit, Tom used a router to first cut away a notch across under side of the sill, similar to the one on top. He made a guide frame which kept the router horizontal. Then he chiseled out the deteriorated wood in the center of the sill, being careful not to totally destroy its longitudinal integrity. He fitted 'new' pieces of SYP and epoxy glued them into each cavity—gigantic 'dental work'.

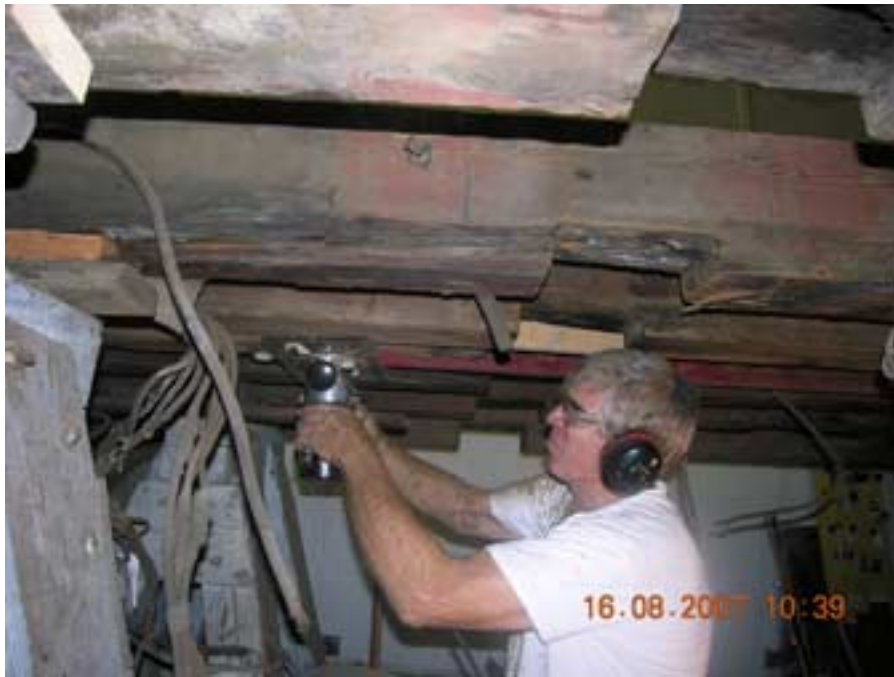
Tom Dow routing out deteriorated wood on bottom of longitudinal sill

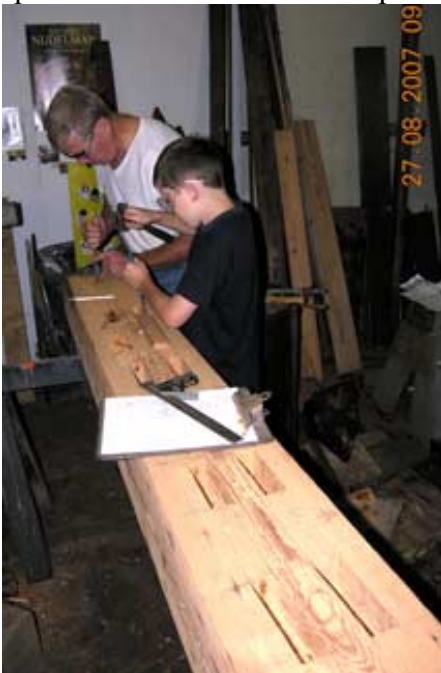
Under grandfather's watchful eye, Christopher Healy Dow learns how to chisel out a mortise in the new end sill

**Step 5. Cutting the mortises and drilling for the through-rods.** Although we have a large hollow-chisel mortiser, capable of cutting the mortises, it would have been very awkward to manipulate the big<sup>8</sup> end sill on the router table as well and hold it in place. So Tom decided we should drill and chisel them. Using a big multi-spur bit in the Rockwell drill press and hand chisel, this was done quite quickly.

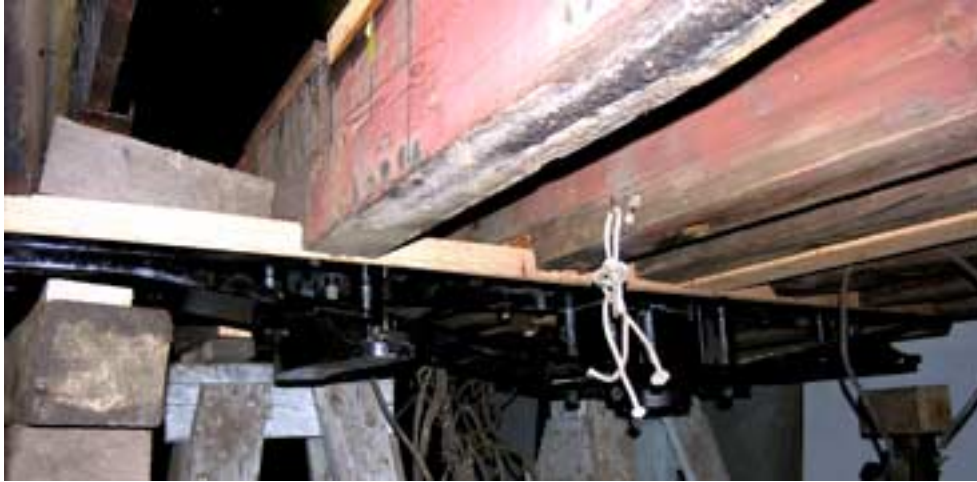
New body bolster trial installation

**Step 6. Installing the body bolster** – As mentioned above, this critical piece of the locomotive’s structure was bolted to the sills. Using a Masonite template, Tom bored 13/16 in. holes up from below through the top of the sills. Then he and **Dick Avy** jacked the new bolster up against the frame and dropped the bolts right down through where they fitted perfectly. The bolster now is temporarily in place for ‘show’ but will have to be dropped when we treat<sup>9</sup> the surrounding wood and add caulking.

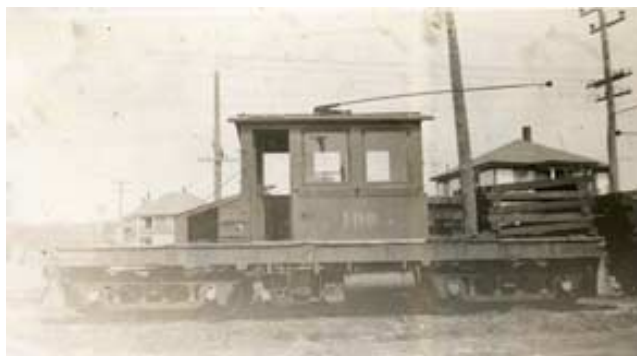
At the River Street Car House, probably late 20s early 30s  
In the process of having current (GE CP30) air compressor installed under missing hood.
