## Atlantic Shore Line Locomotive 100

### Curatorial Report no. 8

10 September –16 December 2007

by Donald G. Curry, Shop Manager

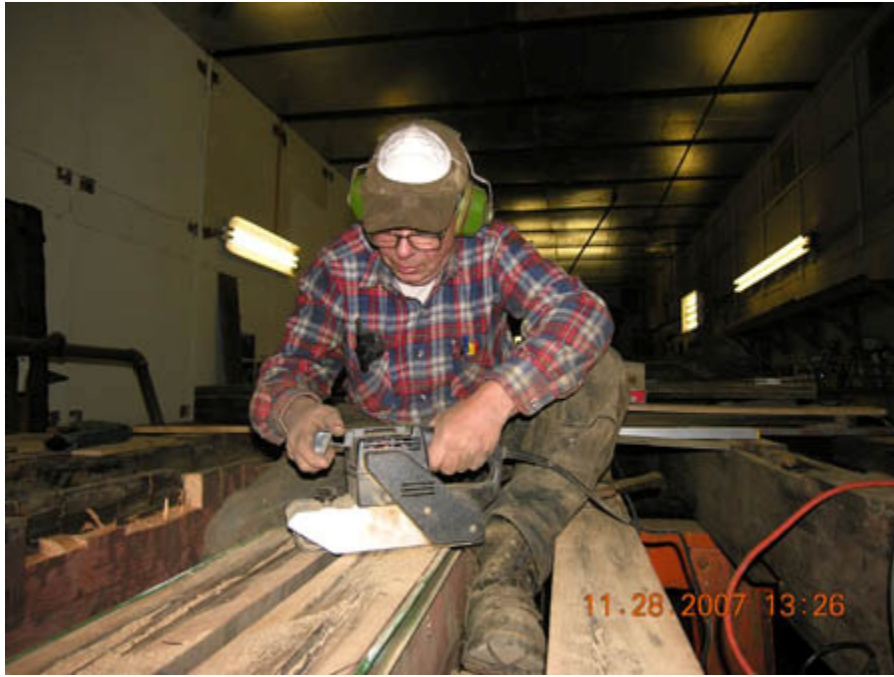
The ex I. S. M. belt sanding the cut-down sill tops

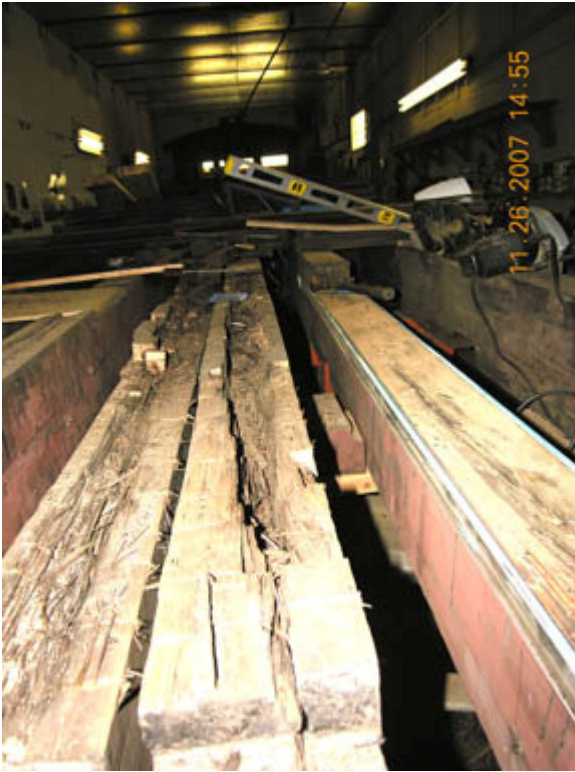
We found the undersides of several of these are also quite bad. No. 2 is rotted out in the center for about 1 ft. on each side of the bolster. No. 5 (it and no. 4 absorb the force of the coupler) suffered from longitudinal splitting, so we have chiseled and sawn off most of its bottom. At the bolster, under each of the eight sills, is a 2 x 8 notch for the bolster filler. These notches have 'eroded' upward at least ½ in. and some more than that, so we are chiseling and routing out an inch or more to get to a solid area to which we will epoxy 'new' wood. So far we have removed about 5 ash cans filled with chopped up rotted SYP from this end an amount which is about equal to that which we removed from the no. 1 end.

Sills 5 & 4 showing deteriorated areas

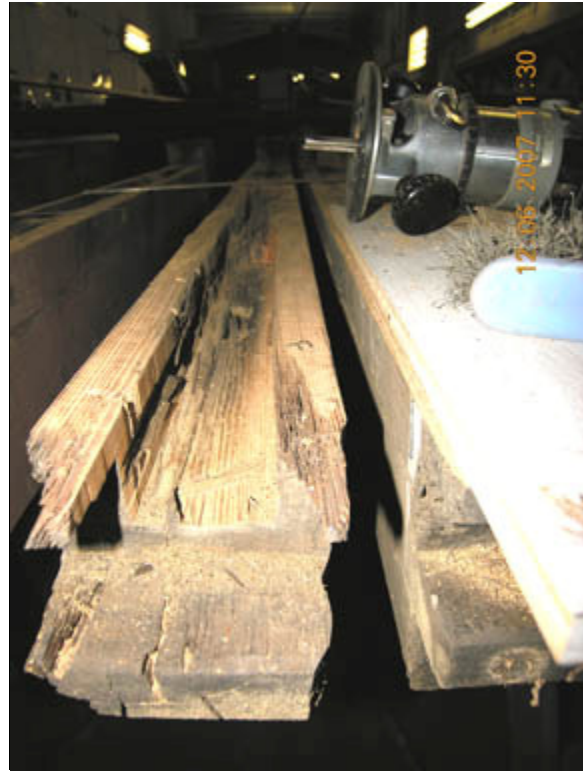
Sill 5 with rotted area routed out

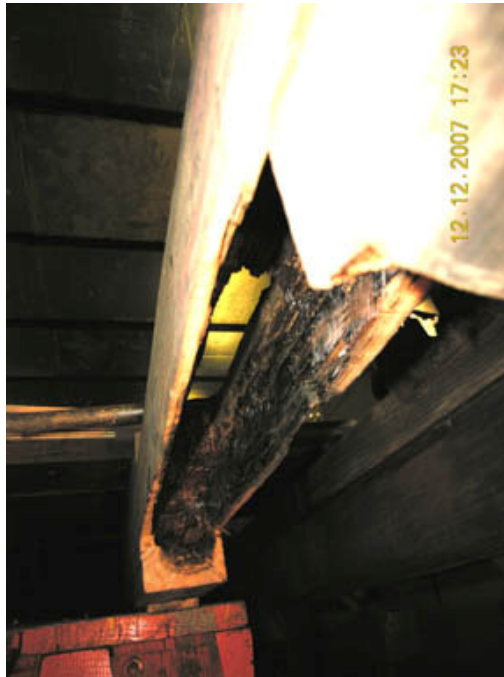
**Preserving the integrity of the original sills** - It was important that we not simply cut a sill all the way through because it would be extremely difficult to make any kind of splice that would hold, so we were careful to preserve enough of the original wood in each sill so it would ‘stand’ on its own. It is amazing how solid they were considering in sill no. 2 we had removed about 75% of its cross-section!

Sill 2 bottom after removing deteriorated wood

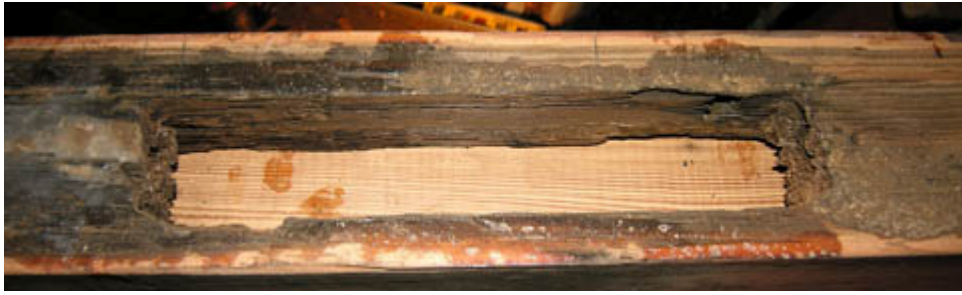
Sill 2 bolt hole area removed-new bottom installed

**Plugs at the bolts.** Because the bolster will have forces exerted on it in both longitudinal directions every time the locomotive is moved, it is necessary to return as much strength as possible to these areas. As the bolts worked back and forth, the holes themselves have enlarged. This was coupled by much of the surrounding wood has softening up or disintegrating along grain lines. (SYP tends to split apart in this manner.) On at least four (and probably five) of the longitudinal sills, we have had to carve out about 2 in. wide by as much as 18 in. longitudinally for a SYP plug to be dropped into these holes. After fitting, it is coated with thickened West System and clamped down in position. Then un-thickened epoxy is poured in around it so it fills up the inevitable gaps. (It's important to close up any gaps at the bottom or the resin will run out onto the floor below.)

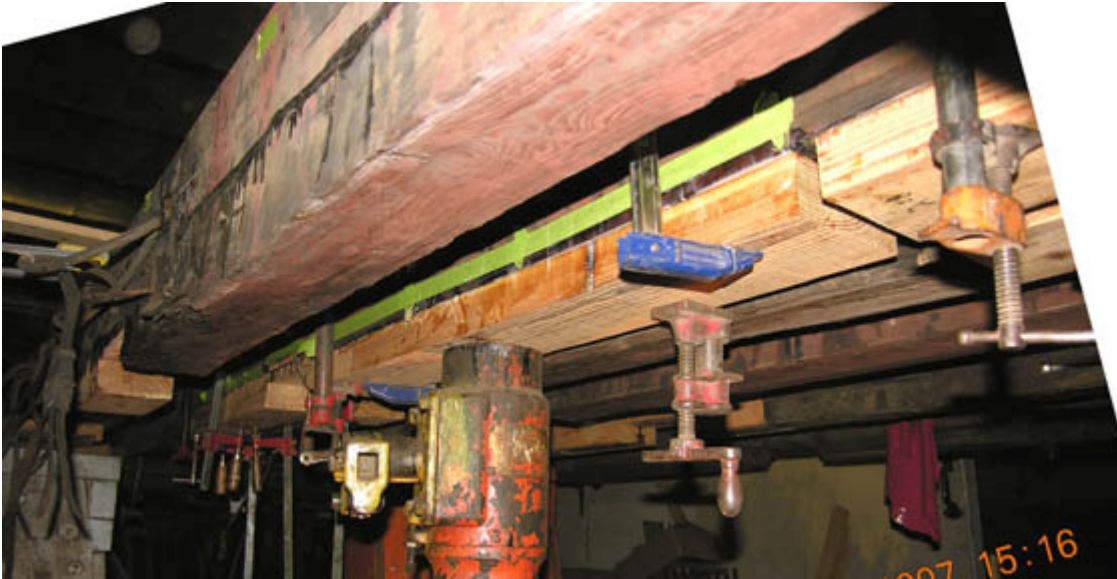
New sill bottom showing jack and many clamps

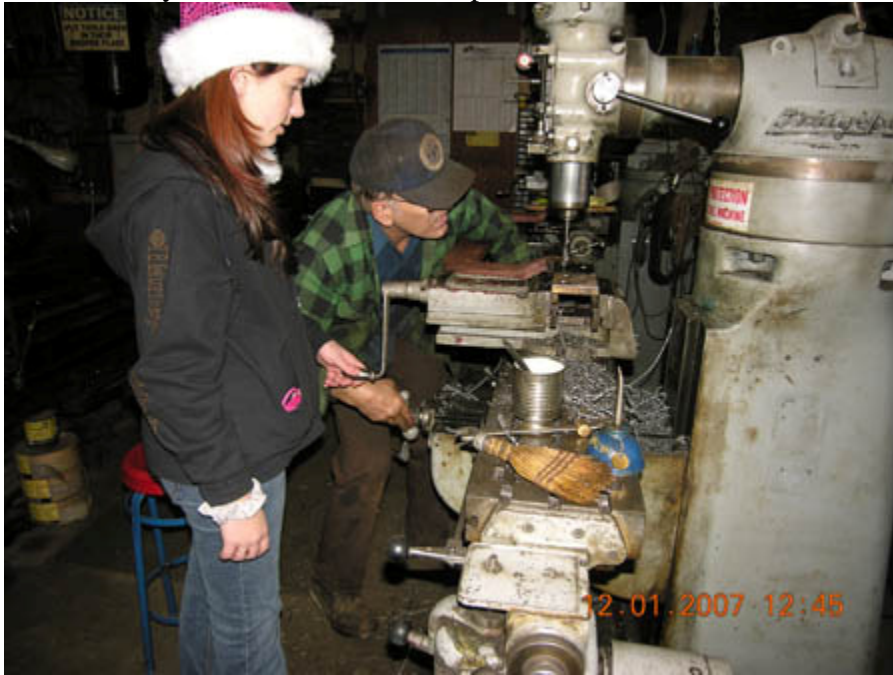
One of Santa's Elves (Chelsey Pino) watching Dean Look prepare to machine a new end for a brake beam

**Truck work** – Last year **Randy Bogucki** started replacing the corroded ends of the brake beams, but his new job with GE in Erie, PA, took him away. So **Dean Look** just completed the first pair. Because they were somewhat crudely forged by Laconia (or Alco), it was difficult for Dean to tell what original dimensions should

be so he had to take a guess. The ends of these locate the brake shoe heads, which must be correctly placed to keep the brake shoes in line with the treads of the wheels. We won't know until we actually install them how much 'tweaking' will be necessary. Two more are still in place on the no. 2 truck to be used as patterns
