**Atlantic Shore line Locomotive 100**  
**Curatorial Report no. 9**  
17 December 2007 – 13 January 2008

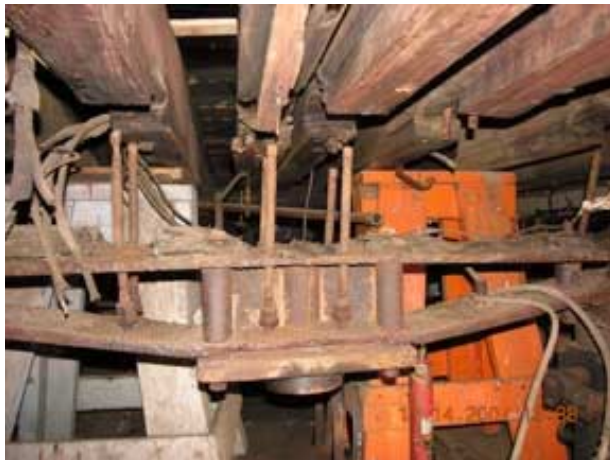
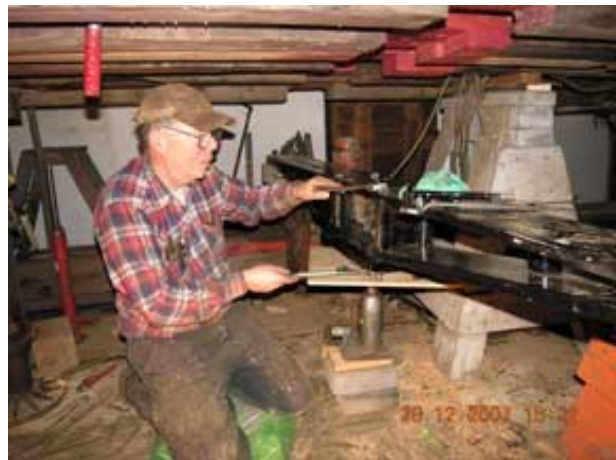
No. 2 end original bolster and Donald Curry installing new one

As we put them together we noticed that YUCo had installed shims between the side bearing castings, the center bearing and the bottom of the bolster frame. Those on the side bearings are rectangular pieces of steel about ½ in. thick. Over the center bearing the two pieces are strips of steel about 4 in. wide x 18 in. long with a large scoop out of each to make clearance for the king pin. We wonder why they felt they had to do this because the castings are shaped to 'surround' the bottom plate of the bolster? These ridges on each casting are about ½ in. high so, with the shims in place, the only thing which keeps these castings in place is the tightness of the bolts. Could it be the springs in the trucks or the wear of the wheels lowered the height of the couplers so they didn't meet those on freight cars properly?

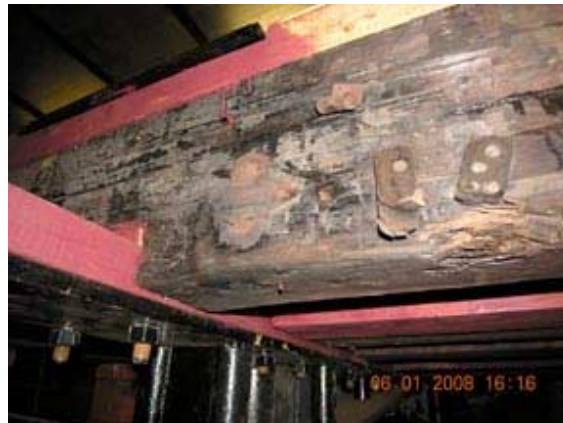
There is strong evidence of a wiring fire between sills 6 and 7 above motor no. 4. The surface of these sills was charred to a depth of about ¼ in. (The motor wiring in general seems to be a patchwork of spliced and friction taped bits, so there probably were other incidents of this sort that didn't get to the point of actually starting a fire.) Using the random-orbital sander with 60-grit paper this area was quickly sanded down to solid wood and given a coat of Cabot's stain.

Sill 6 showing charred area of wiring fire in motor no. 4 leads,

and remains of leather mounting straps for motor wires

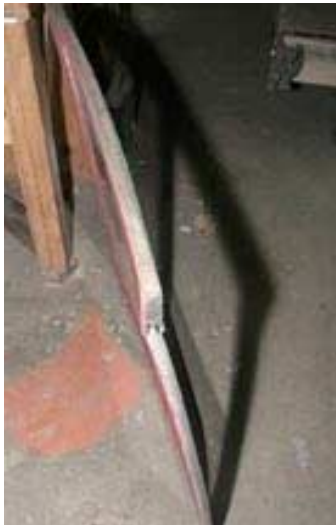
Bent cab sash

One of the side sash appears to have been a replacement. Whatever wood was used was certainly not kiln dried and has warped about 2 in. along the stiles (sides) (bow-shaped) from being straight. We will have to make a new sash in this case while the others appear to be salvageable.

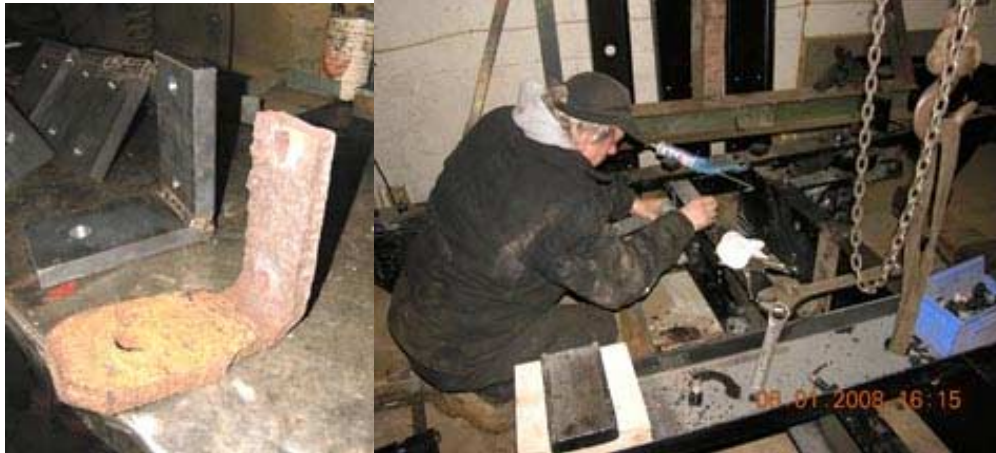
Old and new motor mount angles (before trimming corners)  
Bill Pollman installing them on the truck frame

**Truck work** – **Dean Look** fabricated new motor mount angles to replace the eight originals that are badly rust-eroded. The original angles were bent from 1 x 4 in. bar in Alco's blacksmith shop, very likely using a steam or mechanically operated bulldozer. Dean joined these from two lengths of the bar by beveling one end of each piece and filling them with weld. **Chuck Griffith** trimmed off the corners of the angles and ground the welds. **Bill Pollman** and **Bert Rendall** primed and painted them. Bill is now fitting and installing them on the first truck. Dean fabricated eight motor mount bolts from  $\frac{3}{4}$  in. rod and square nuts. **Lloyd Rosevear** blasted them, preparing them for Bert to prime them.

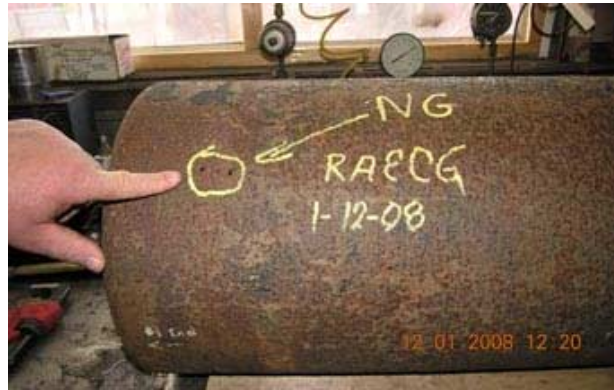
in each. On both the failure was under where the supporting straps were—not an uncommon thing.<sup>4</sup> They also found that the auxiliary tank had been brazed in at least two places, not a good sign. Both tanks were unusable.

Holes in the main reservoir

So we set out to look at our large and varied supply of air tanks, scattered here and there on the grounds. Unfortunately many were buried in snow and all are in areas which make them subject to corrosion. We did find one 16 x 60 in. as a replacement for the secondary main reservoir. Fortunately there is room for the larger tank on the locomotive's left-hand side where there is only that tank. The auxiliary reservoir will be a very new tank, constructed in 1999. This tank was designed to be mounted to brackets welded to the tank but we plan to carefully remove them and return to the original strap style of mounting. Because there are two tanks on the right side there is limited room so it can't be any longer than the original 36 in. (The distance between the trucks is short. Given the poor conditions under which our spare tanks are stored, it's very likely many more of these tanks will fail their test. Thanks go to **Dan Cohen** for assisting in this search.

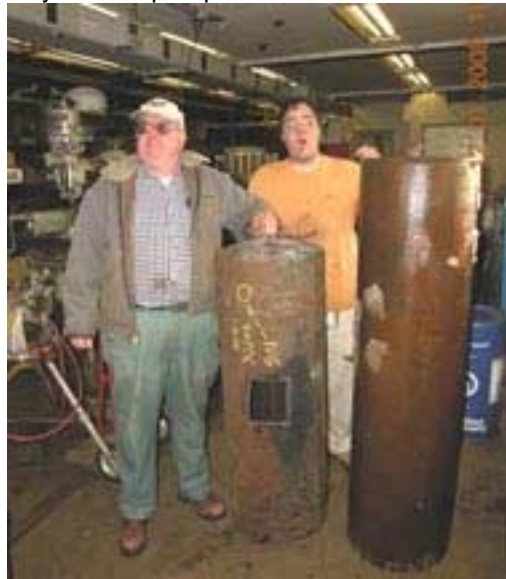
Dick Avy and Mark Sylvester with original main reservoir and replacement
