Atlantic Shore line Railway Locomotive 100
Curatorial Report No. 4
6-20 February 2007

Donald G. Curry, Interim Shop Manager
Seashore Trolley Museum

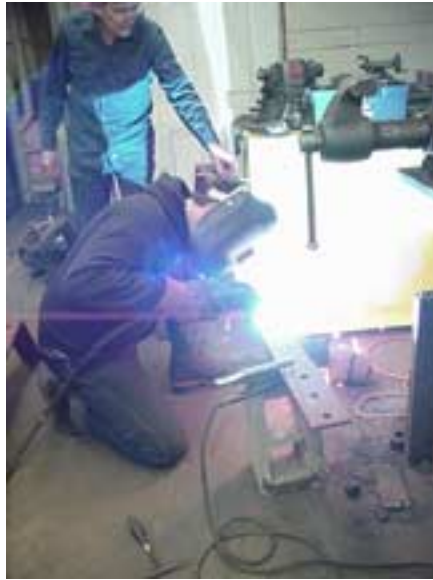
Randy Bogucki building up pits in truck arch bar,
(No Dean isn't actually looking, despite what it may look like!)

Chuck Griffith spent many hours with filling the pits in the equalizer frames. He used the stick-welder, grinding them quite smooth. We are down to the last two of the eight and these are the best so will require less attention. **Randy** did a similar operation on the arch bars. **Bill** has found several of the small castings involved in the brake mechanisms have cracks and one had been brazed at some point. We will repair all of these.

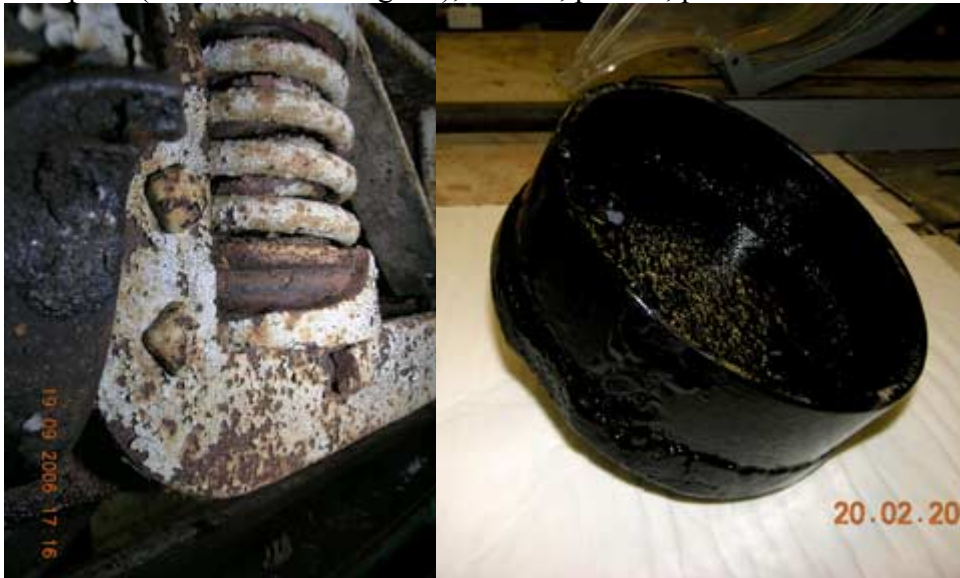
Spring cups are all complete (5 rebuilt and 3 original), blasted, primed, painted.

Original cracked spring cup and rebuilt and repainted² one.

² We don't know where the gray paint originated—probably at Seashore. Of what little remains in the hidden areas, all is black.

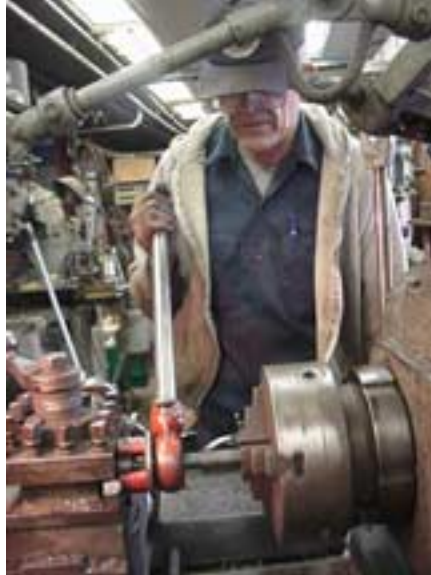
Dean Look threading a rod before installing bolt-head

We purchased a number of 20 ft. hot-rolled steel rods. First these were cut to length by **Randy Bogucki**. Then **Dean Look** threaded them. This was done using a combination of the American Lathe and the Rigid pipe threader (power rotating vise) and (for $\frac{3}{4}$ and $\frac{5}{8}$ bolts) the Rigid OO pipe threader. There are still more to do but unfortunately the threading die broke from just plain hard work. We have ordered another and expect it on the 20th.

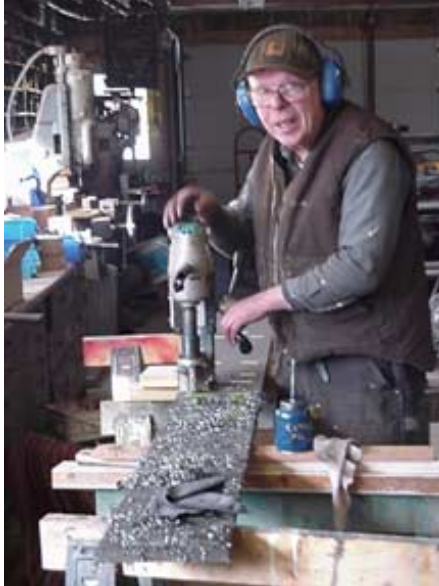
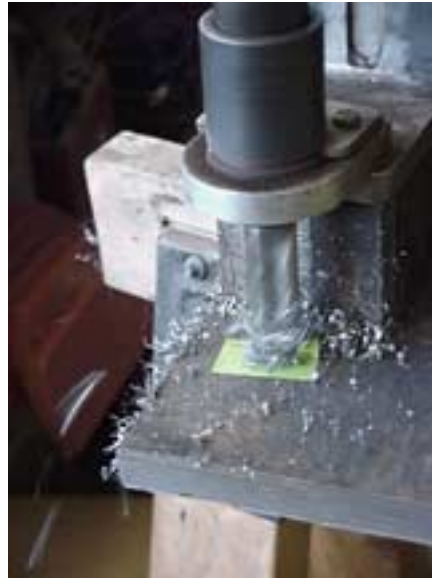
The Jancy Magnetic-based drill and the *Rotabroach* in action.

Using the Jancy magnetic-base drill and the *Rotabroach* “*Slugger*” bits, with **Norman Down**’s help we were able to drill through the $\frac{3}{4}$ in. plates many times in a very short time. We were even able to drill the 2 in. diameter hole in the center through which the king pin projects. In this case we used a hole saw and the drill press.⁵ The plates came back from A. C. Electric and have now been painted black.

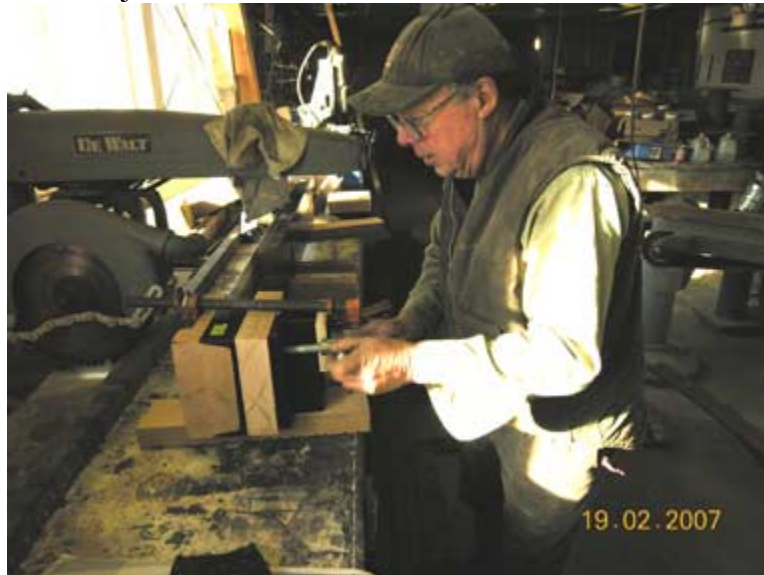
Interim Shop Manager installing lag screws in spring plank assembly

Spring Planks – This afternoon we assembled the first spring plank. Apparently it was not uncommon to have wood fillers in this area and 100 is a good example. There is an oak block on top of and below the 'plank' (actually an 8-in. channel). The upper is angled to fit snugly inside the tapered edges of the channel's flange.

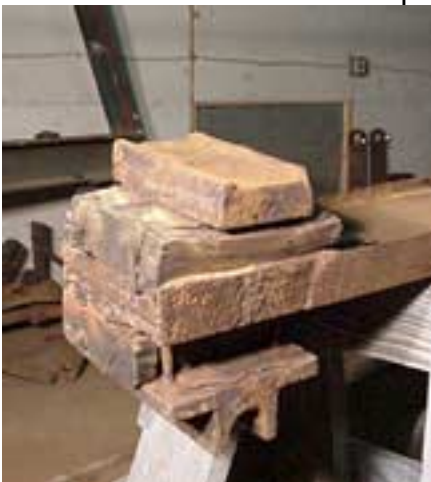
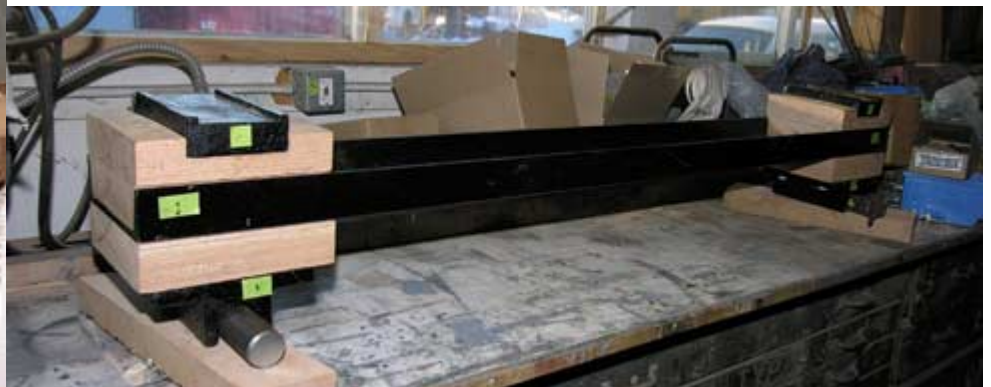
Original and new spring plank assembly
(The wood on either side of the top casting had broken away on removal.)

The top casting is the seat in which the elliptic spring rests.

The bottom casting is for the swing link pin which is suspended from the transom by the swing links.

We have made a slight change in design, hopefully back closer to the original design. The spring plank we have just assembled will replace the currently rusted-too-thin channel. At some point ASL or YUCo welded 1 x 7 in. steel plate on the inside of the channel but, because it didn't go all the way across, it really didn't appear to do much and the channel bent anyway. (For whatever reason it is straight on the other truck despite being likewise reinforced.)

We are not going to put in the plates, so to keep the bottom casting through which the rod for the swing link is passed, the same length, we are changing the thickness of the upper oak block—adding about $\frac{3}{4}$ in. We have only made the blocks for one truck just to be sure this will work.
