Atlantic Shore Line
Locomotive 100
Curatorial Report no. 2
1 – 16 January 2007
by Donald G. Curry, Interim Shop Manager
Seashore Trolley Museum

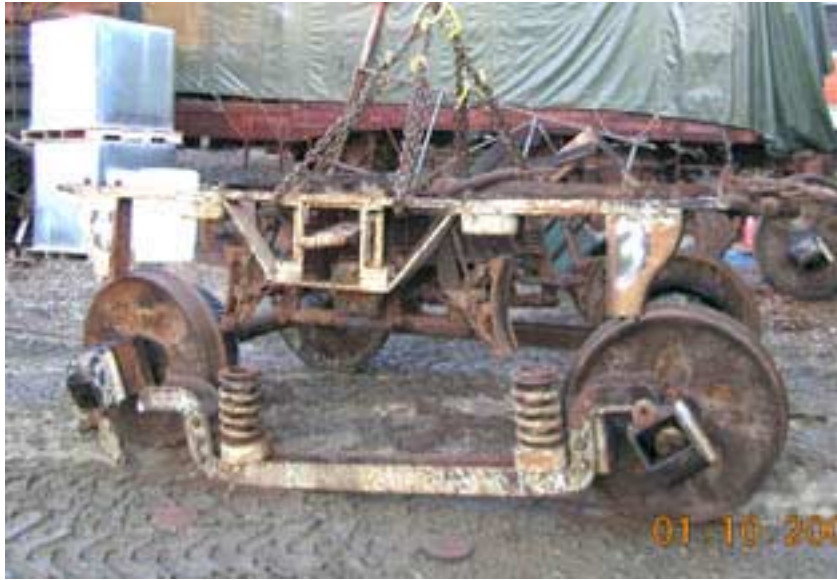
Lifting the truck frame

Most of the equalizer coil spring sets came out of their bottom mounting ‘cups’ but several also were stuck with a major buildup of rust and required a bit of ‘persuasion’.

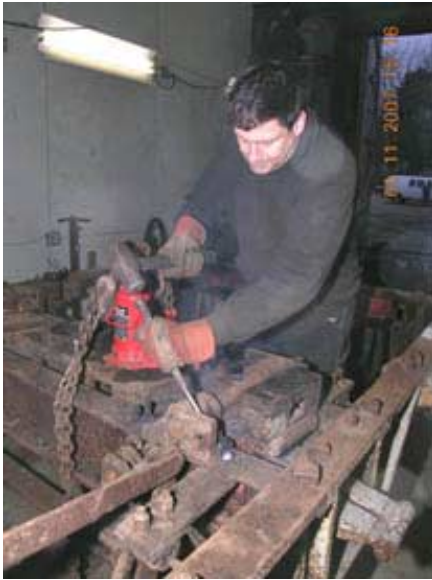
This past weekend: 13-14 January, **Bill** and **Randy** ‘attacked’ the actual frames. The first task was to resume one started the week before—removing the elliptical bolster springs. These come in pairs, tied together at the end by bolts through eyes on the end. They are made up of a stack of individual curved ‘leaves’ (plates), of spring steel bound together by a heavy strap (band) in the center. The bolster on which the car (locomotive) body rests sits on these which, in turn, are supported by a heavy ‘swing’ link underneath. In some sense it’s a ‘bomb’ waiting to go off because the swing link pivot pin at the top and the bearings at each end are bolted to the transom. These bolts had disintegrated so there was not much holding the springs down.

Randy Bogucki driving out swing link bracket bolt
Squeezing the bolster elliptic springs

To release the tension, it was necessary to make a loop of chain around the entire transom including a 20-Ton hydraulic jack resting on the bolster next to the swing link pin. On the first try, it didn't work well: the jack was low on oil so it didn't have much lift and nothing seemed to move anyway. The next try was more successful: better jack and some other assistance from another jack. Then the bolts which held the bearings for the swing link were cut, the jack released and *voila*, the spring was no longer under tension (or is it pressure?) There's nothing like experience because the other three sets came out in no time with minimal effort. Releasing and removing the springs also revealed a lot of things we really didn't want to see and which difficult, if not impossible to evaluate properly when the trucks were under the body.

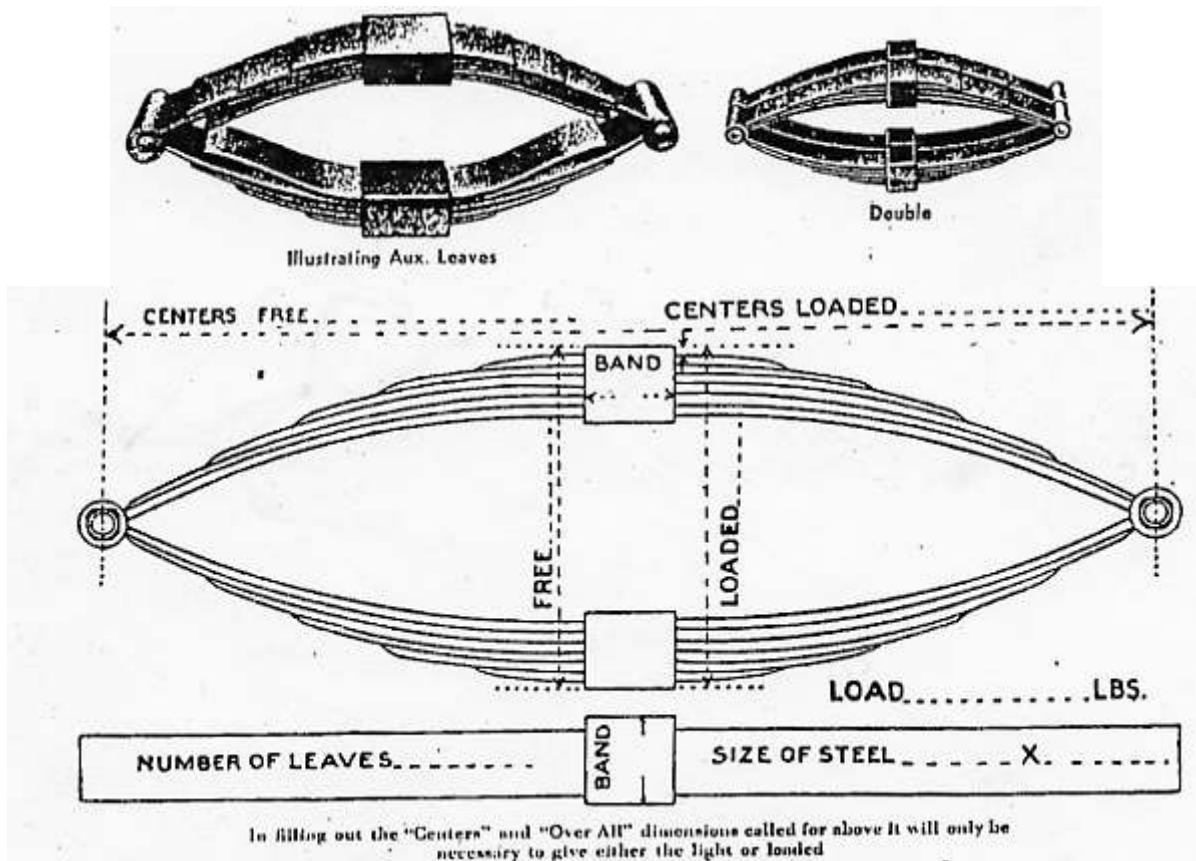
More evaluation of other components will take place as further disassembly is done. Many of the bolts have corroded and/or crystallized and should be replaced.

If nothing else, the hardware should be replaced. One of the more time-consuming parts of this job has been to remove the rust-welded bolts. So, once that is done, it's not that much more work to overhaul the components.

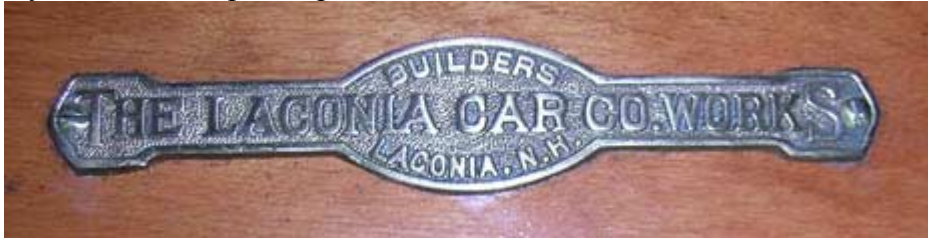
Missing builders plate

While looking at replacing the deteriorated leather hand straps in Manchester car 38, I happened to notice its beautiful Laconia Car Company builders plate obviously missing in 100. (Only its outline shows now.) Does anybody have one they would like to put on permanent loan in 100?
