Atlantic Shore Line Railway Locomotive 100
Curatorial Report no. 5
21 February – 18 March, 2007
Donald G. Curry, Interim Shop Manager
Seashore Trolley Museum

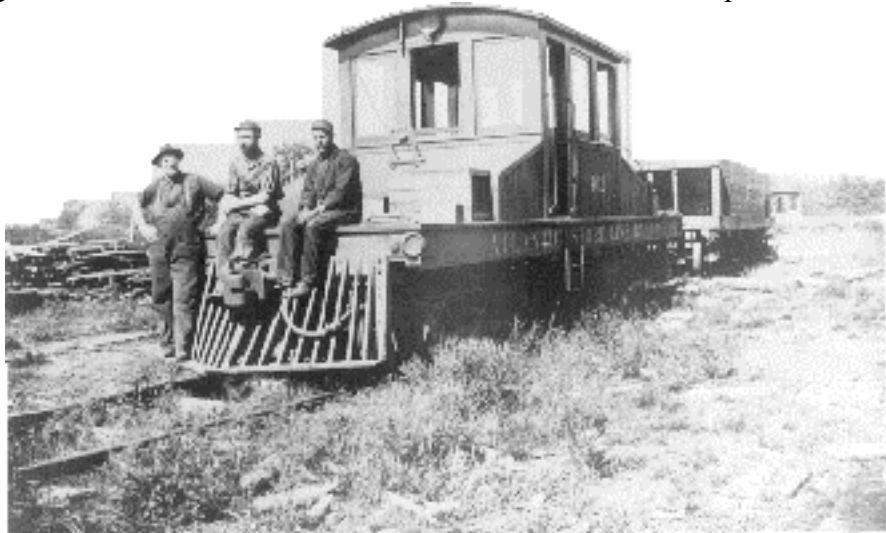
102 COAL POCKET SHED

In 1908, the Atlantic Shore determined they needed enclosed carrying space for their express business rather than another locomotive. So they converted 101 from the 'cab-on-raft' style to a box motor, retaining its couplers so it could pull a freight car if needed. Its cab was then added to 102, the configuration it had until the end of its life. We have a photo probably taken in the yard around the coal pocket across the road from Town House; showing 102 in its original configuration with must have been three members of the barn crew sitting on it. Off to the right in the background is what David feels (and I agree), sort of leaning slightly to one side, is the cab from 101 waiting for installation on 102. Could this have been a 'before' photo?

102 about to be double-cabbed? Is that 101's cab in the background?
