**Atlantic Shore Line Locomotive 100**  
**Curatorial Report No. 6**  
19-31 March 2007  
by Donald G. Curry, Interim Shop Manager

Seashore Trolley  
Museum  
Locomotive 100

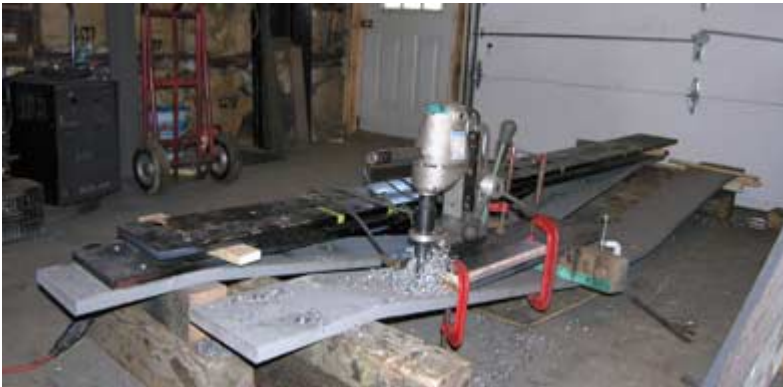
**Body bolsters** – The first job on these was to set up the 1 x 8 in. (read very heavy!) bottom plates for drilling. A previously drilled top plate was clamped top of each one and the 13/16 in. *Rotabroach* was run down through into the lower plate. This worked well most of the time but on one hole, despite the strength of the magnetic base of the drill,<sup>2</sup> it broke loose at a hard spot in the steel. Because the drill was already in more than 1 in., it had no lateral 'give' and snapped. So we quickly ordered another, this time carbide-tipped to cut through the hard spots and just started the hole in the 1 in. plate to mark it; then slid the upper plate to the side and successfully completed the drilling.

**Drilling body bolster with *Rotabroach***

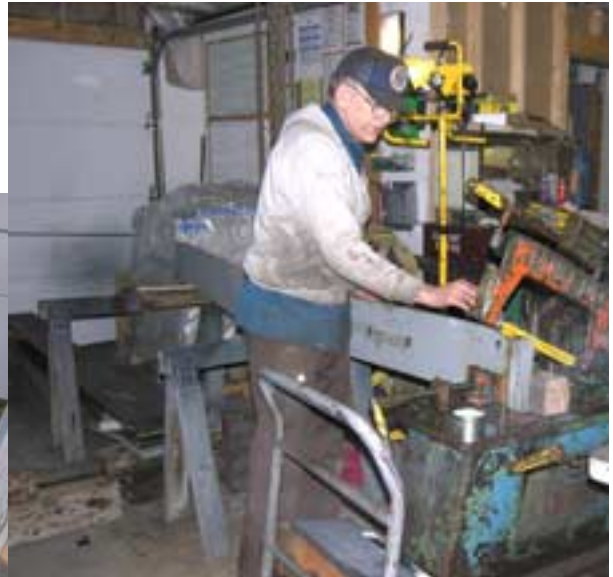
**Dean cutting off end of lower plate.**

First we had to cut off excess length from the bottom (bent) plate. We rapidly discovered the capacity of our tools was not up to that. The small horizontal band saw would take forever and wouldn't cut straight anyway. It would be difficult to hold a piece in the vertical band saw, which also wouldn't cut very straight. The abrasive cut-off saw would go through a stack of blades before all four cuts could be made. However we still had the old fashioned Toledo reciprocating hack saw.<sup>3</sup> It looked large enough and was certainly heavy. We were disappointed to discover it wouldn't cut anything over 6 in. wide—but **Dean** came to the rescue saying that we could do it half-way through on edge; then turn it over and do it the rest of the way—which he did. The surplus blocks were then cut into the pieces to form the hooks, one of which Dean welded into place. It will then be ground to a half-round cross-section, duplicating the appearance of the original.

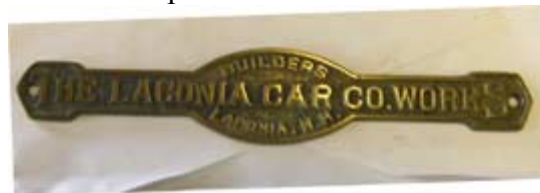
**Welcome finds** – This afternoon we received a very welcome donation, prompted by **Peter Folger's** e-mailing of previous reports. (We're glad somebody reads them this carefully.) **Win Nowell** brought in an original Laconia Car Company bronze builders plate, exactly like the one that was taken from 100's cab years ago. We will have this duplicated as a bronze casting and put the original in secure storage. Within an hour, **Dan Cohen** said he and **Tom Santarelli** had been cleaning out Baltimore Semi-convertible car 5748 to make temporary storage room for Graham-Dodge bus parts. They found a 12-in. GE air whistle, exactly of the type needed to replace one taken from 100 at some time in the past.<sup>4</sup>
