**Atlantic Shore line Locomotive 100**  
**Curatorial Report No. 7**  
1 April--9 September 2007  
*by Donald G. Curry, Shop Manager*

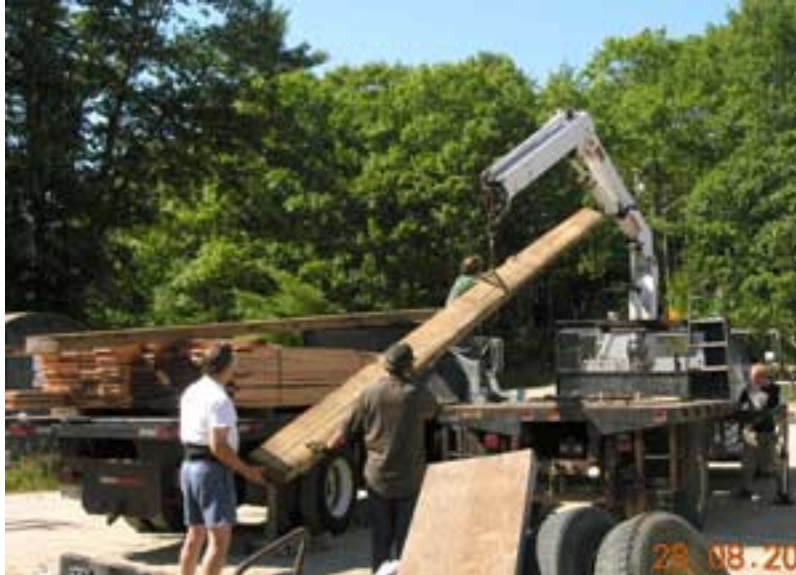
Danny Cohen operating Mr. Lifto while Ed Dooks, Dean Look and Randy Leclair handle the long side sill

On 29 Aug. Barnstormers! John Rousseau finally arrived with the two 30 ft. 6 in., 5 x 11 ¾ in. side sills. **Dan Cohen** was of invaluable assistance with “Mr. Lifto”, the truck with the hydraulic crane and flat bed, in getting off the long sills. In fact, with **Randy Leclair** and **Ed Dooks’** help, he slid each sill the full length of 100 so one is positioned on the floor on each side, right below where they will eventually end up. Barnstormers! also brought down the big end sill for the no. 2 end and the two 2 x 8 x 104 in. spacers which go across the top of the body bolster through notches in the longitudinal sills.
