**Atlantic Shore line Locomotive 100**  
**Curatorial Report no. 9**  
17 December 2007 – 13 January 2008

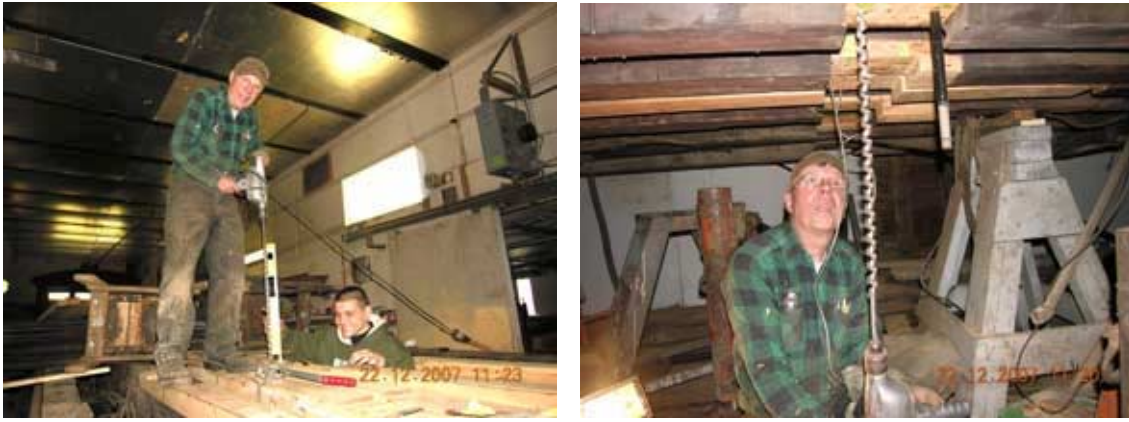
<sup>1</sup> The original bolsters were so badly corroded, it was impossible to get an accurate layout of the holes, we could only guess where they were.

Drilling for bolster bolts with help from Brendan Barlow

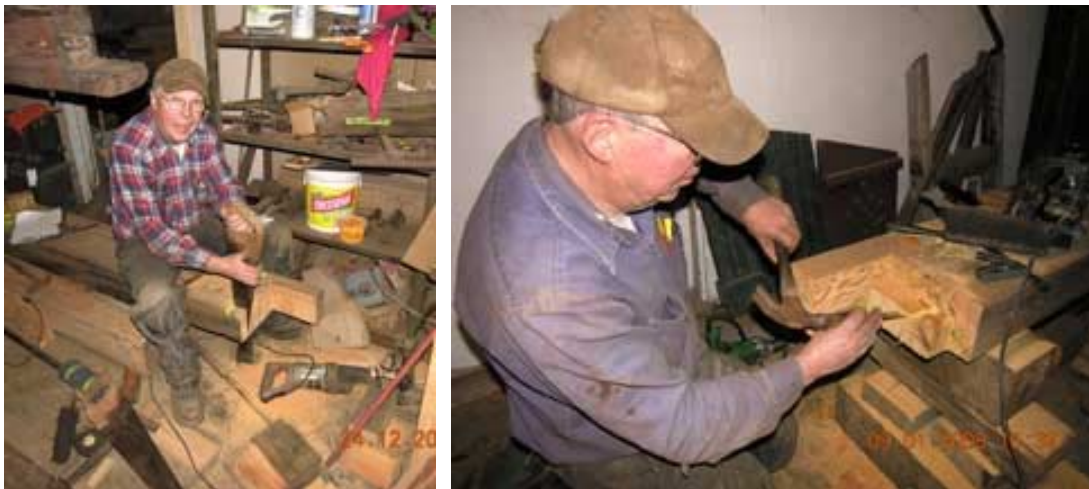
We would love to have seen the huge machinery at Laconia Car Company which made the two tenons on each end of the sills. We didn’t have that advantage. After carefully laying them out, we cut the tenons with a combination of circular saw (which could only get half-way through the 5 in. thickness), a very coarse-toothed timber saw and a chisel. On the bottom end of each sill we copied the ‘aerodynamic’ curve of the original, telling people this apocryphal tale:

This involved cutting with the coarse saw followed by some ‘trimming’ with the very coarse belt sander.

Forming ends of the long sills

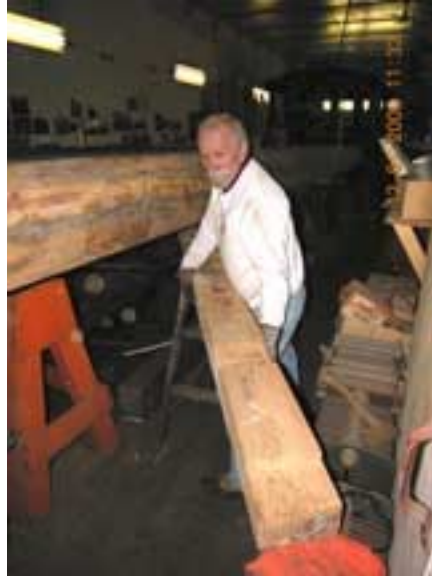
**Cross sills** (needle beams) - About 1/3 of the way down the body from each end is a cross sill, 5 x 7 in. s.y.p., with notches in the top into which the longitudinal sills were set. These must have served to hold the sills in line as the frame was constructed. There is a ¾ x 14-in. square head bolt going down through the sill and holding the cross sill in. place (two each on sills 4 and 5). Their other function

is to hold and be the anchor for the casting<sup>2</sup> under which the longitudinal truss rods pass. The truss rods also pass through the end sills and the pole pockets in each corner of the car. As the big square nuts on the ends of the rods are taken up, the truss rod, which is now unsupported in the middle bows way down, will tend to straighten and provide a lifting—straightening force to keep the outer sills straight. **Donald Curry** did the notching in the sills and **Fred Poore** assisted in getting them into place.

Fred Poore installing needle beam

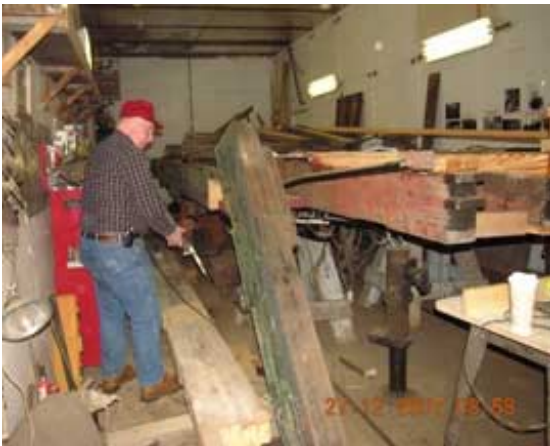
However, first the old sills had to be removed. Fortunately **Paul Cronin** arrived right in time to do the necessary bull work. There were a number of bolts that required the use of the Sawzall, then driving out to be turned into no. 1 scrap. He cut the no. 1 (original) sill into ‘bite-sized’ chunks about 8 ft. long so they could be taken out.

Paul Cronin cutting off old sill

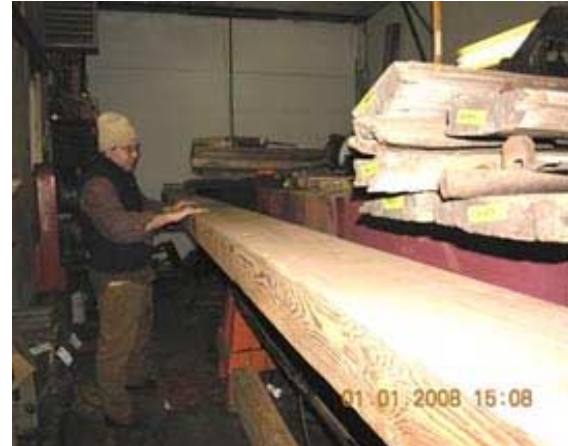
**The long sills** – as you look at the front of 100 from the no. 1 end, the sills are numbered 1 through 8 from left to right. The original no. 8 sill has been gone since 1965, replaced by a large spruce timber by an enthusiastic group of early Seashore restorationists. On 12 January, a ‘new’ no. 8 s.y.p. sill was hoisted into place by **Fred Poore, Randy Leclair, Dick Avy and Chuck Griffith**. The no. 1 sill had been fabricated and installed the week before.

Randy Leclair with ready to upright new sill no. 1

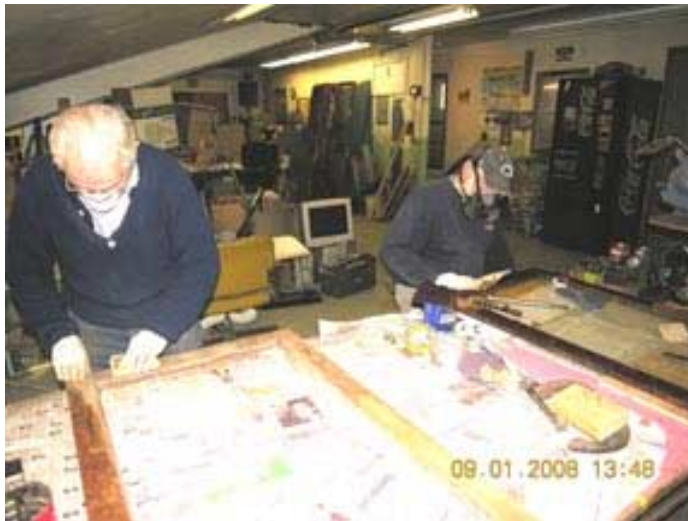
**The cab – Bob Reich and John Fatula** are overhauling the ten cab sash. (six rectangular ones for the ends and four large squarish ones for the sides) The end sash are in pretty good condition although they are repairing any deteriorated joints. They have noted that whatever the original coating on them was, it is extremely hard to remove! Paint remover and elbow grease don't work as well as they would like.

Bob Reich & John Fatula scraping cab end sash

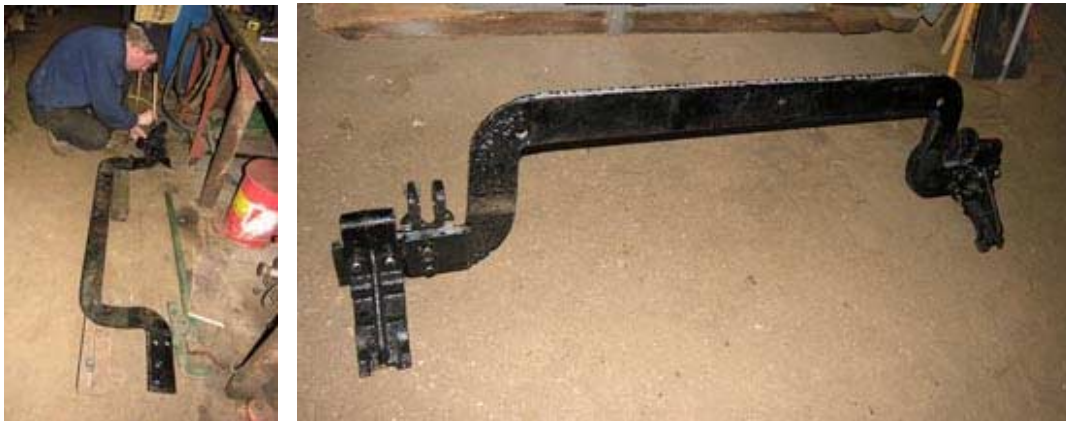
Bill Pollman installing brake shoe head on rebuilt brake beam

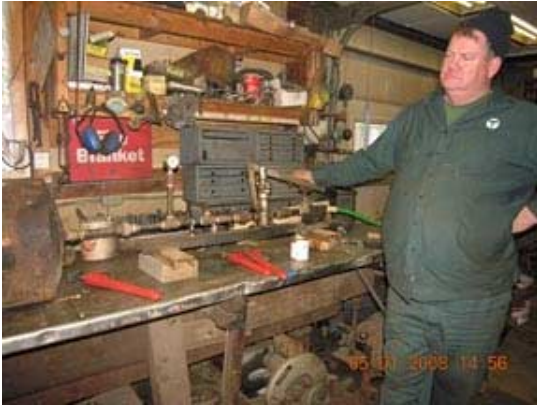
On 5 January they set up the high-pressure test pump and found it leaked to the point it required repacking and a new check valve. Fortunately it is a simple-minded device and was easy to fix. Main reservoir no. 1 passed at 185 lbs. (1.5 times the operating pressure of 110 lbs.) But on 12 January they set up the other two tanks for testing but before they even filled them with water, they found holes

in each. On both the failure was under where the supporting straps were—not an uncommon thing.<sup>4</sup> They also found that the auxiliary tank had been brazed in at least two places, not a good sign. Both tanks were unusable.

Chuck Griffith with hydro-test pump

So we set out to look at our large and varied supply of air tanks, scattered here and there on the grounds. Unfortunately many were buried in snow and all are in areas which make them subject to corrosion. We did find one 16 x 60 in. as a replacement for the secondary main reservoir. Fortunately there is room for the larger tank on the locomotive's left-hand side where there is only that tank. The auxiliary reservoir will be a very new tank, constructed in 1999. This tank was designed to be mounted to brackets welded to the tank but we plan to carefully remove them and return to the original strap style of mounting. Because there are two tanks on the right side there is limited room so it can't be any longer than the original 36 in. (The distance between the trucks is short. Given the poor conditions under which our spare tanks are stored, it's very likely many more of these tanks will fail their test. Thanks go to **Dan Cohen** for assisting in this search.
